# INSPECTION REPORT

CHATSWORTH, CA 91311

Inspection Date: Friday, June 9, 2017

RE: Report No. 1117, v.2

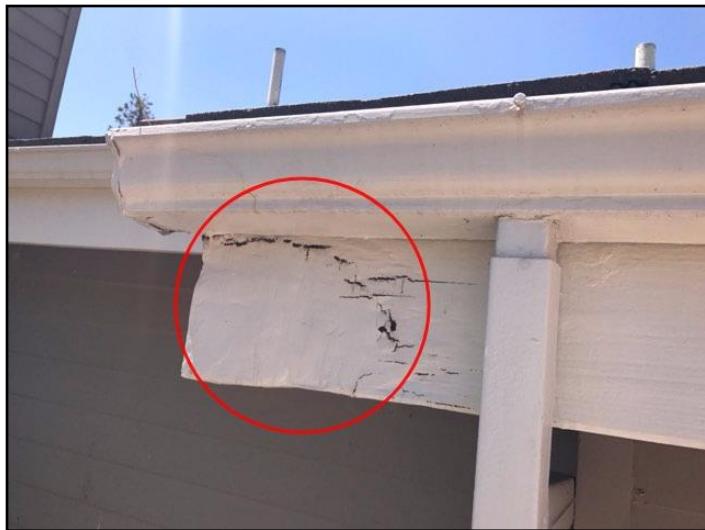
5. Rot or insect damage

Signs of deterioration, dry rot, possible insect damage was noted. Recommend further evaluation by a licensed specialist.

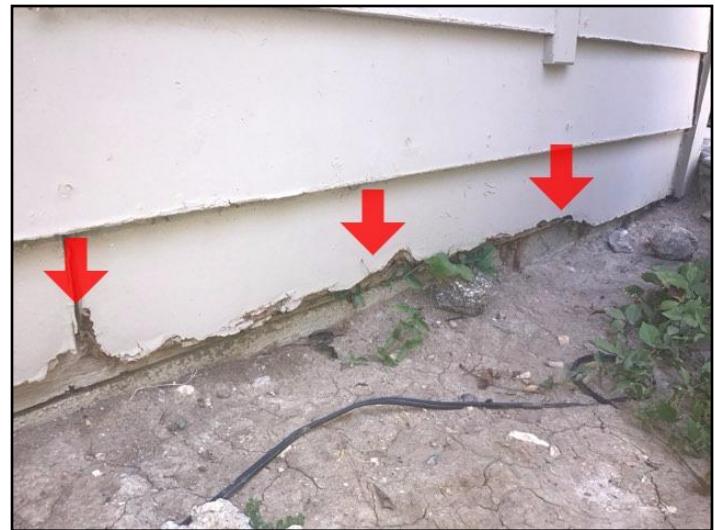
14. Rot or insect damage

Signs of deterioration due to moisture, possible insect damage was noted. Recommend further evaluation by a licensed specialist.

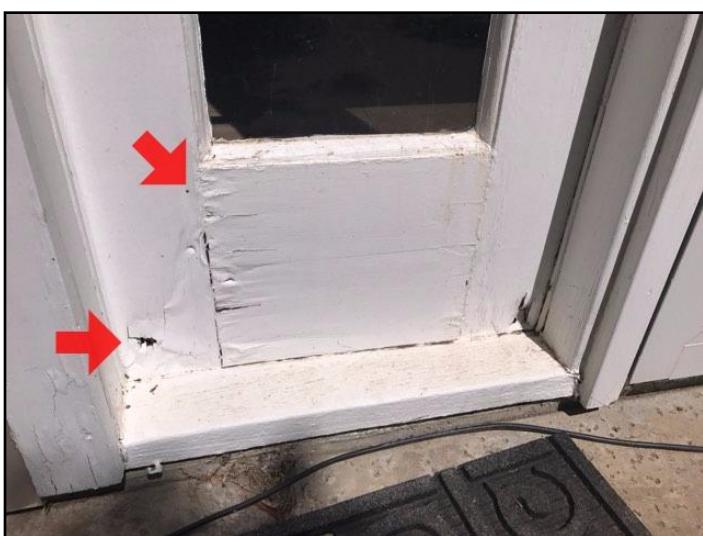
16. Rot or insect damage

Signs of deterioration, possible insect damage was noted to window wood trim. A licensed specialist is recommended to further evaluate.

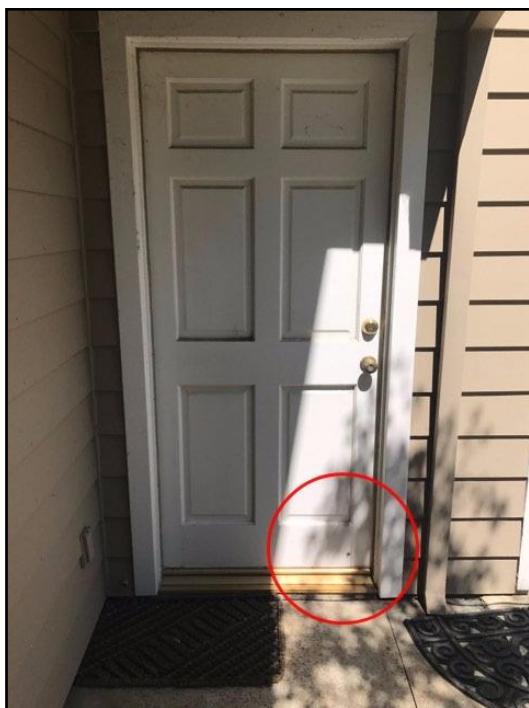
23. Rot or insect damage

Signs of deterioration, possible insect damage was noted to door.

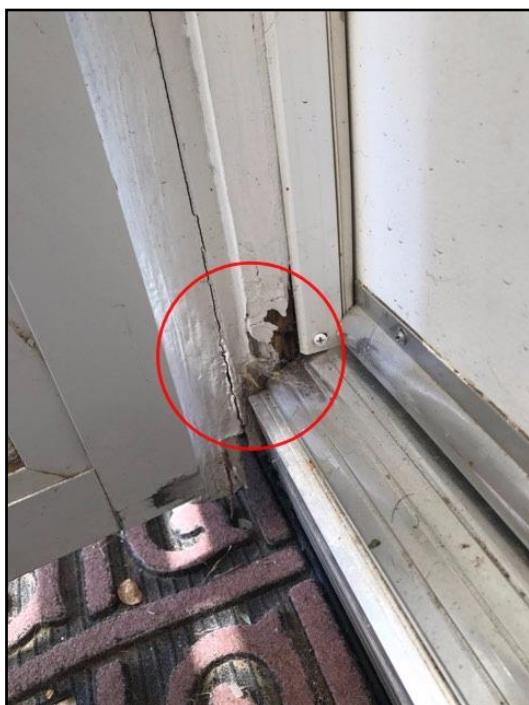
25. Rot or insect damage

Signs of deterioration, possible insect damage was noted to door frame.

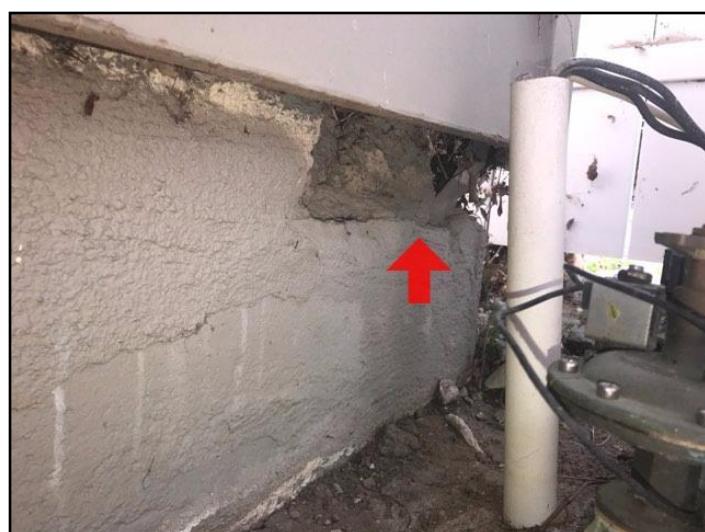
36. Cracked

Chipped concrete noted to foundation. Recommend further evaluation by a licensed professional.

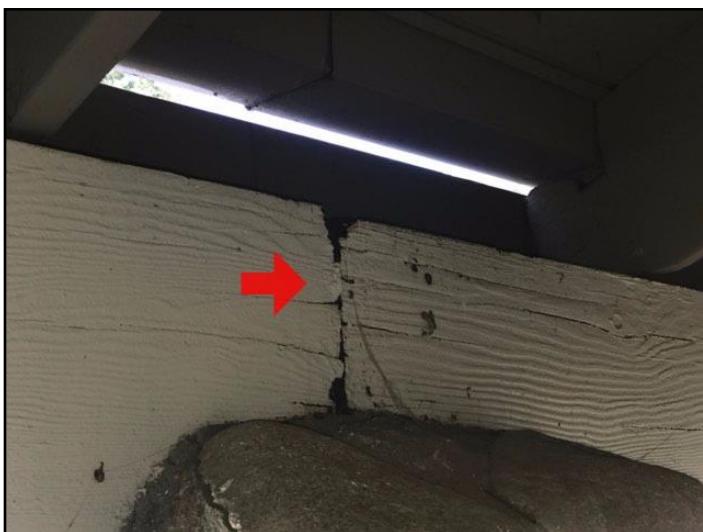
37. Rot

Signs of deterioration, rot, possible insect damage noted. Recommend further evaluation by a licensed specialist.

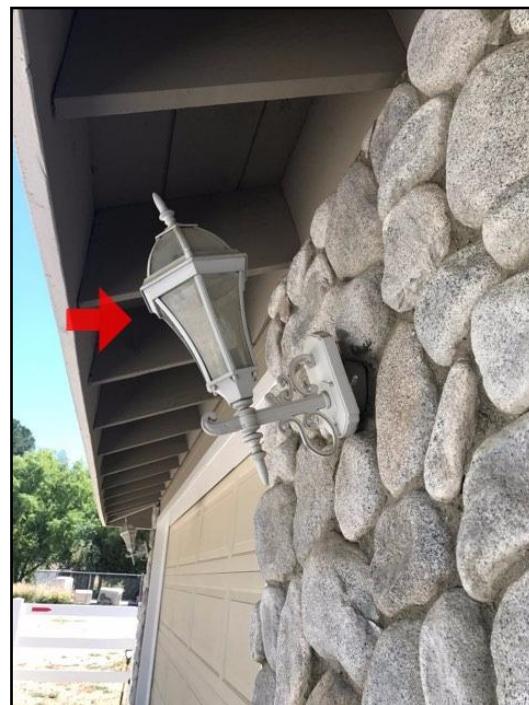
45. Loose

Loose surface mount lights noted. Recommend repairs.

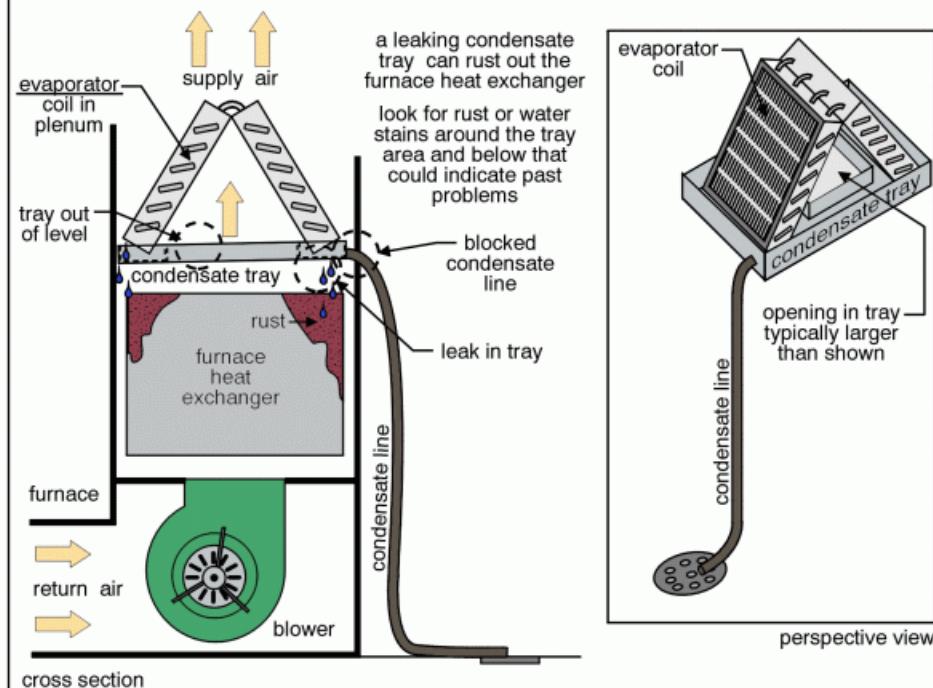
Water pooling was noted at drip pan. Signs of poor drainage at condensation drain pipes. A licensed HVAC specialist is recommended to further evaluate.

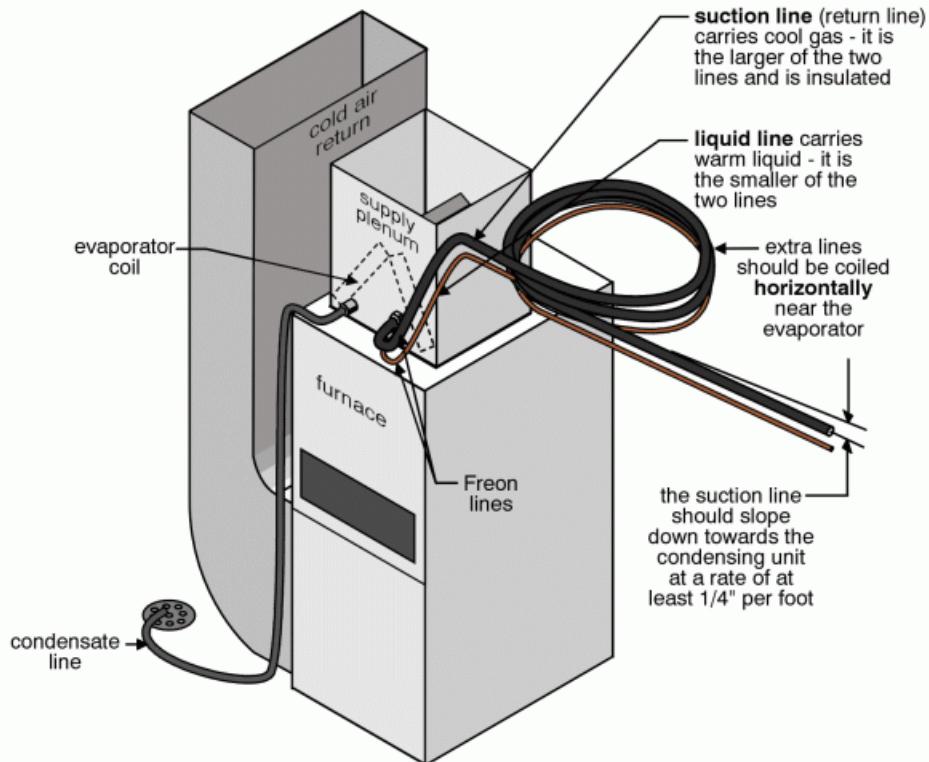
48. Insulation - missing

Missing insulation noted. Recommend installing insulation to prevent lines from freeze.

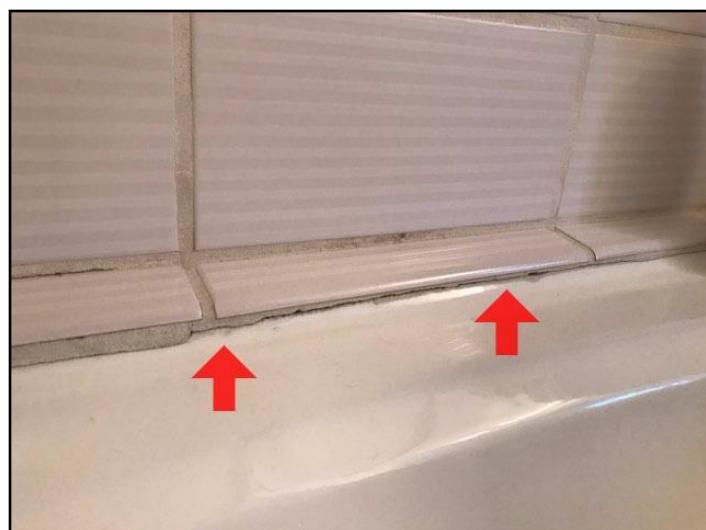
54. Grout loose, missing or deteriorated

Signs of missing caulking/grout noted. Suggest tub/shower edges, tiles be caulked and sealed to prevent moisture penetration. All missing, deteriorated/damaged caulking, grouting should be replaced, Failure to keep tub shower edges sealed can potentially cause deterioration and extensive moisture damage to the interior walls and surrounding sub-flooring. This damage is not always visible or accessible to the inspector at the time of the inspection.

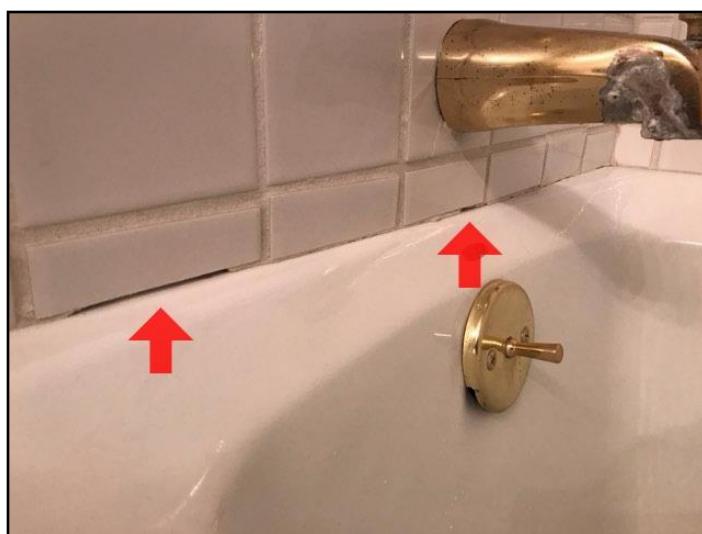
55. Grout loose, missing or deteriorated

Signs of missing caulking/grout noted. Suggest tub/shower edges, tiles be caulked and sealed to prevent moisture penetration. All missing, deteriorated/damaged caulking, grouting should be replaced, Failure to keep tub shower edges sealed can potentially cause deterioration and extensive moisture damage to the interior walls and surrounding sub-flooring. This damage is not always visible or accessible to the inspector at the time of the inspection.

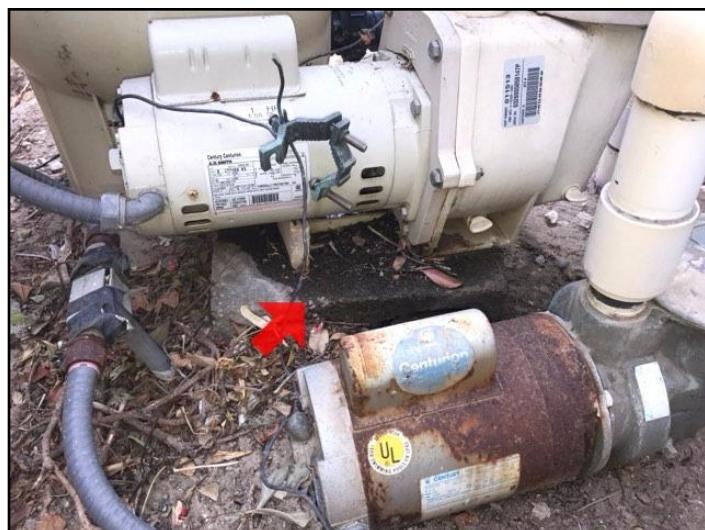
61. Pump leaking

Leak noted at pool pump. A licensed pool specialist is recommended to further evaluate.

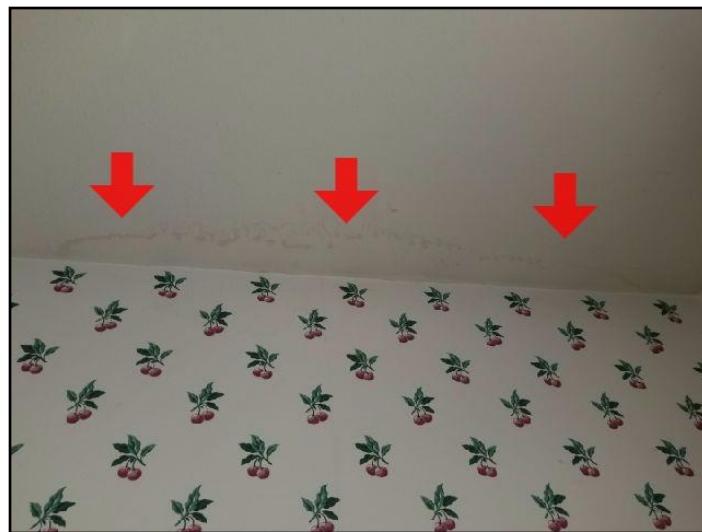
62. Stains

Signs of water/moisture stains were noted to ceiling. Recommend monitoring. A licensed specialist may be recommended to further evaluate.

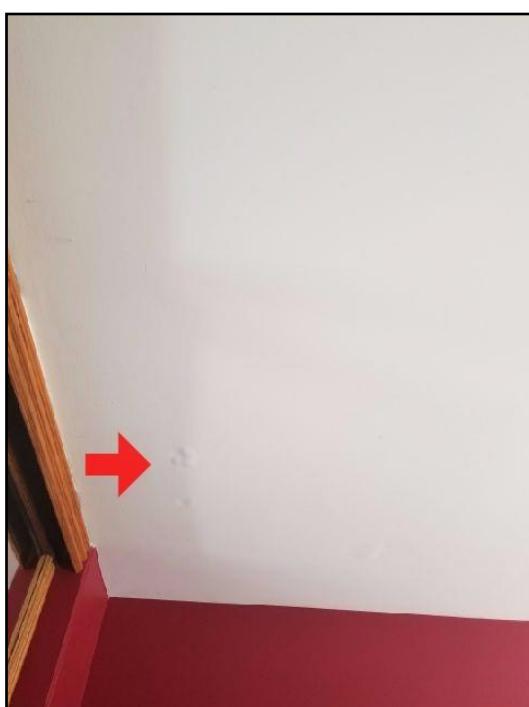
63. Water stains

Ceiling was observed and evidence of deterioration/bubbling surface was noted. A licensed specialist may be recommended to further evaluate.

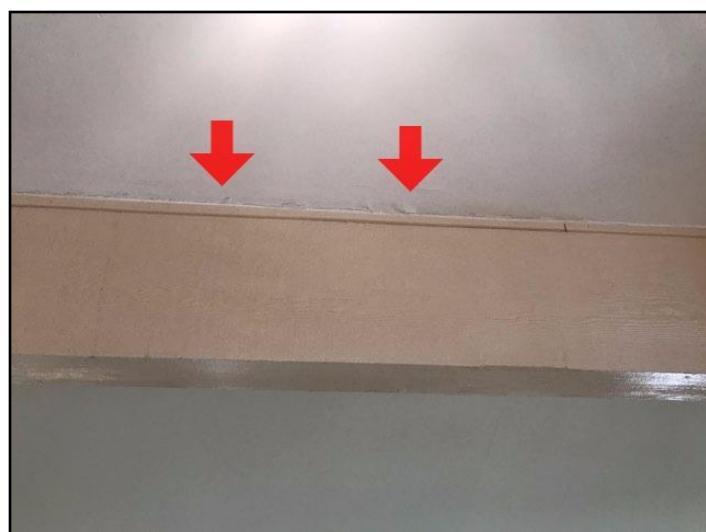
67. Water stains

Signs of water stains, deterioration was noted. Recommend further evaluation by a licensed specialist. Recommend seller disclose.

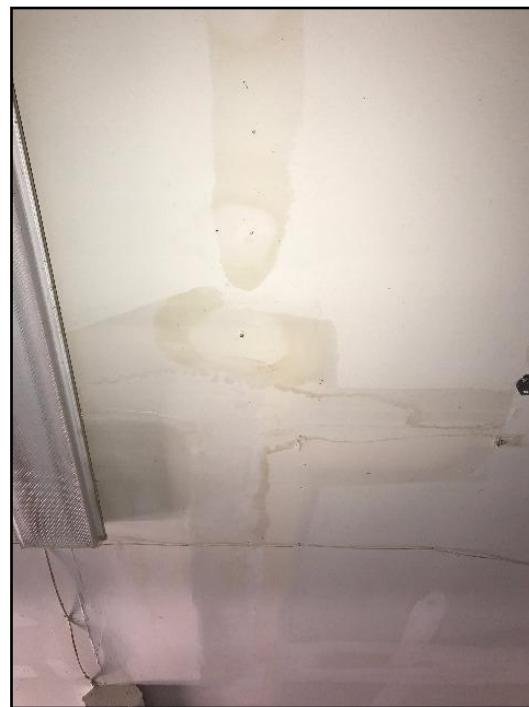
71. Water stains

Signs of water stains was noted to ceiling. Master bathroom at 2nd floor is above the area where the moisture stains were noted. Recommend further evaluation by a licensed specialist. Recommend seller disclose.

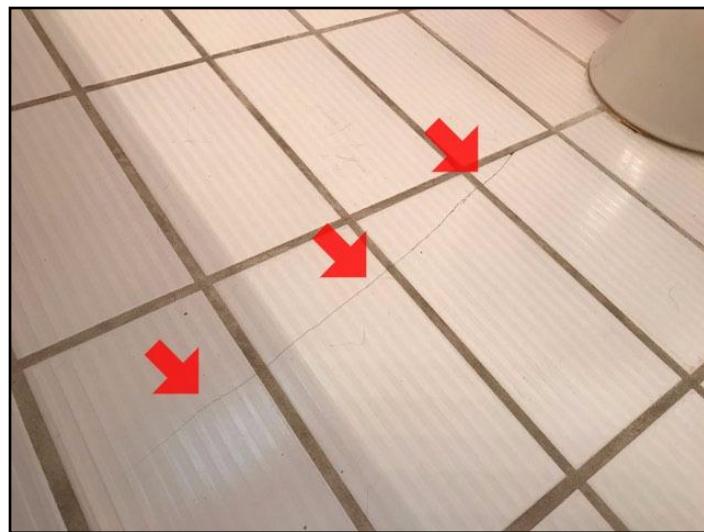
73. Tiles cracked

Cracked tiles noted

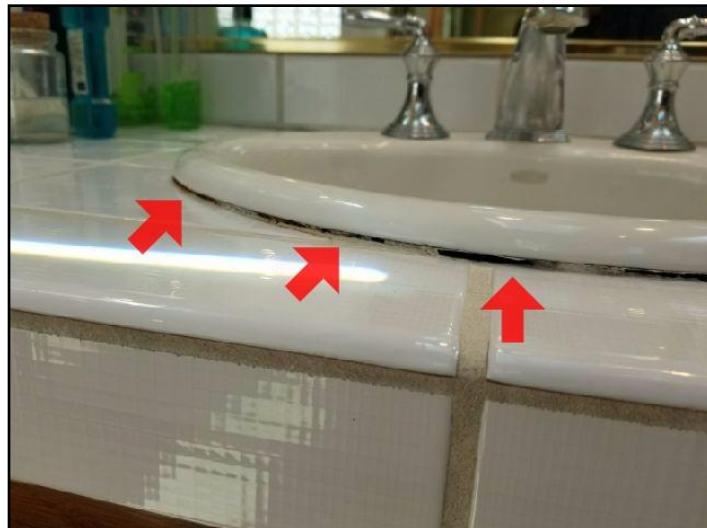
84. Grout loose or missing

Missing grout noted. Recommend repairs to prevent deterioration to cabinet or walls from water moisture intrusion.
