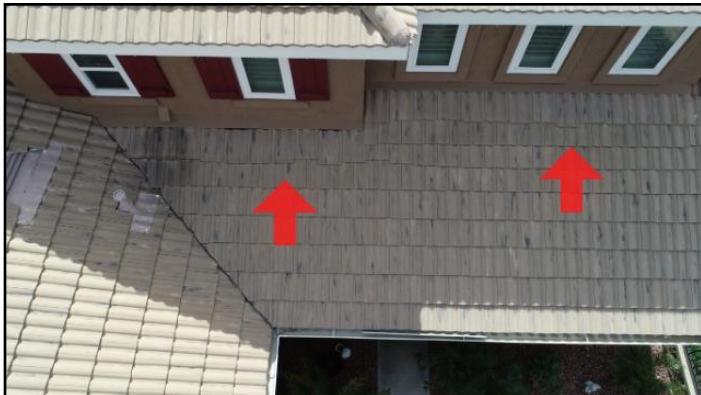
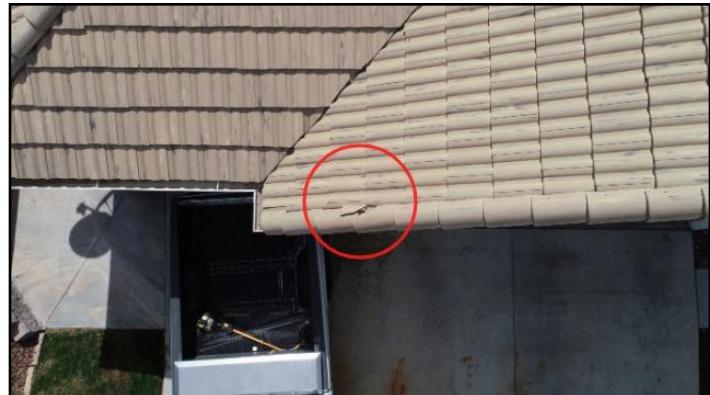
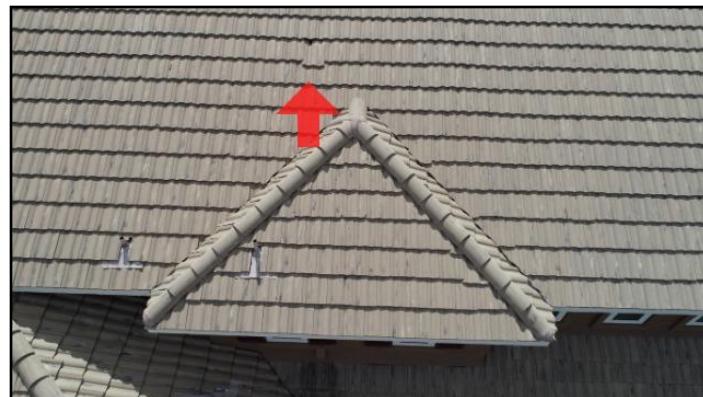
1. Roofing • Sloped roofing

Condition: Clay/concrete/fiber cement • Missing, loose or broken pieces

Location: Various Exterior Roof

Loose/shifted, cracked tile(s) were noted at various areas of the roof. Recommend replacement of cracked tiles.

Recommend securing loose, shifted tiles. A qualified roof specialist is recommended to further evaluate and estimate cost for repairs.

Action: Repair

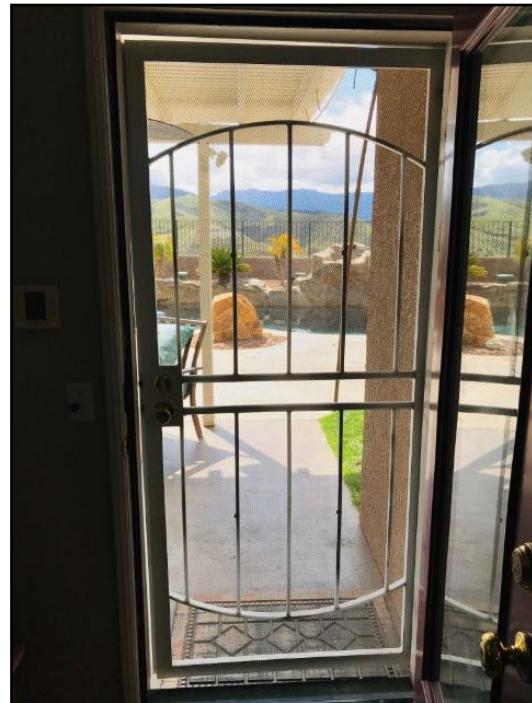
**2. Exterior • Doors**

Condition: Doors and frames • Loose or poor fit

Location: Exterior Family Room

Door is out of square and not fully operable. Recommend repairs for ease of operation.

Action: Repair

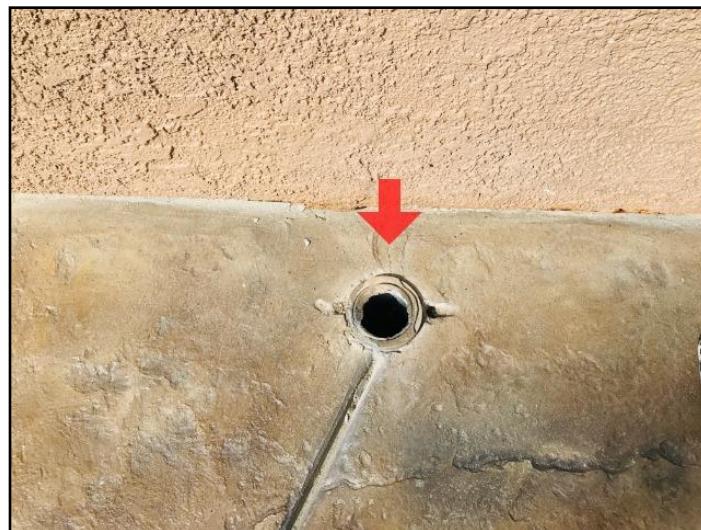
**3. Exterior • Landscaping**

Condition: General • Missing drain screens or covers

Location: Left Side Exterior

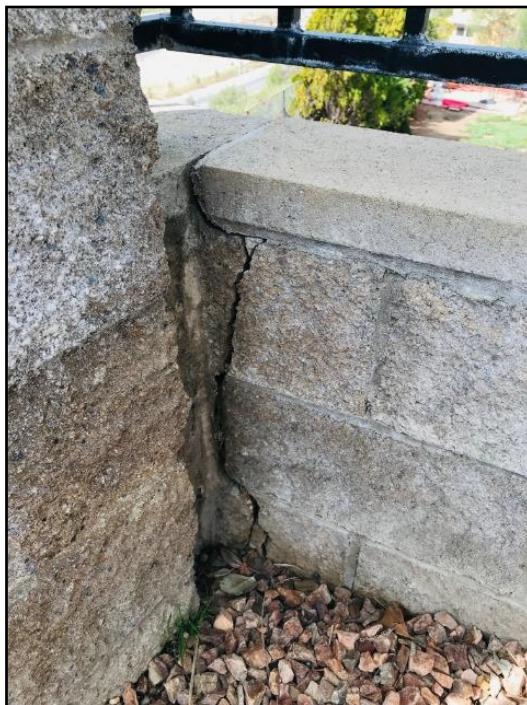
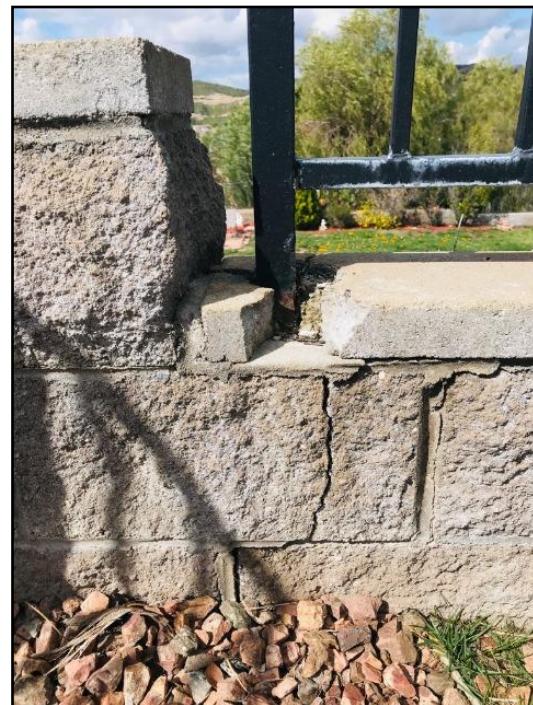
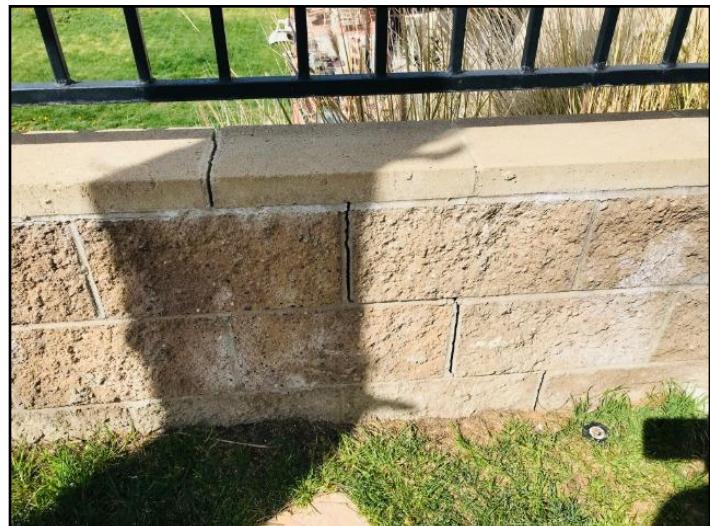
**4. Exterior • Landscaping**

Condition: Retaining wall • Mortar - deteriorated, missing

Location: Various Exterior

Evidence of cracks, deteriorated, missing mortar was noted to block wall. This may cause wall to weaken over time.

Recommend repairs. A qualified specialist may be recommended to further evaluate.

Seller to Repair, Replace, or Credit Buyer.

Action: Repair

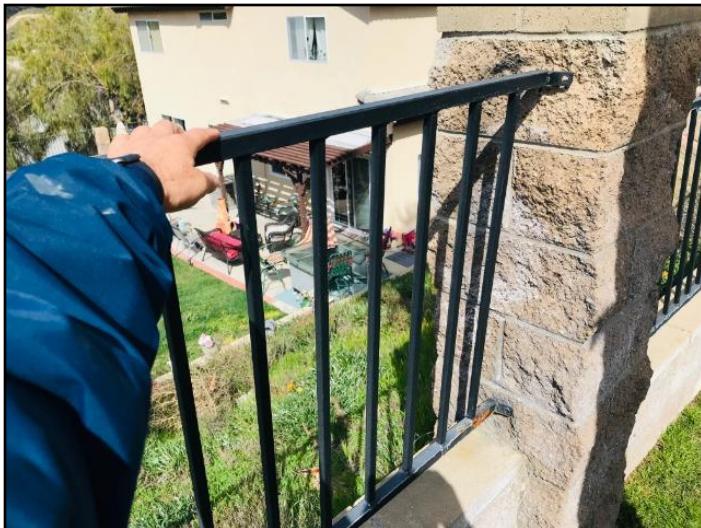
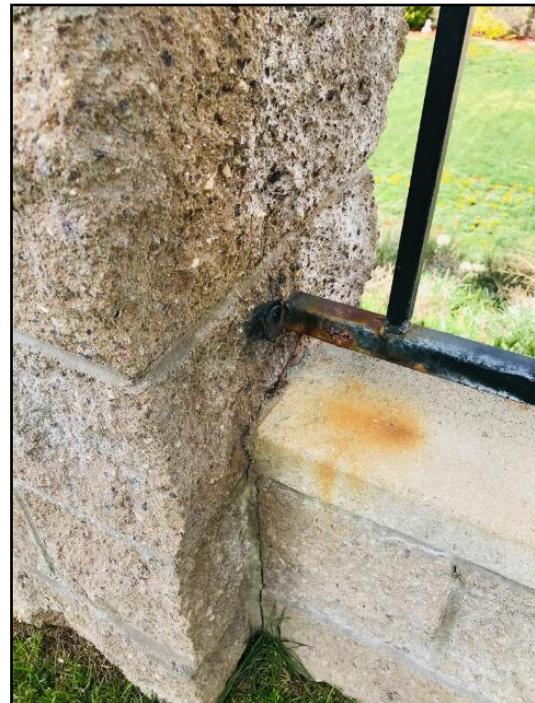
5. Exterior • Landscaping

Condition: Fence • Loose fence

Location: Various Exterior

Loose fence noted. Recommend repairs.

Action: Repair

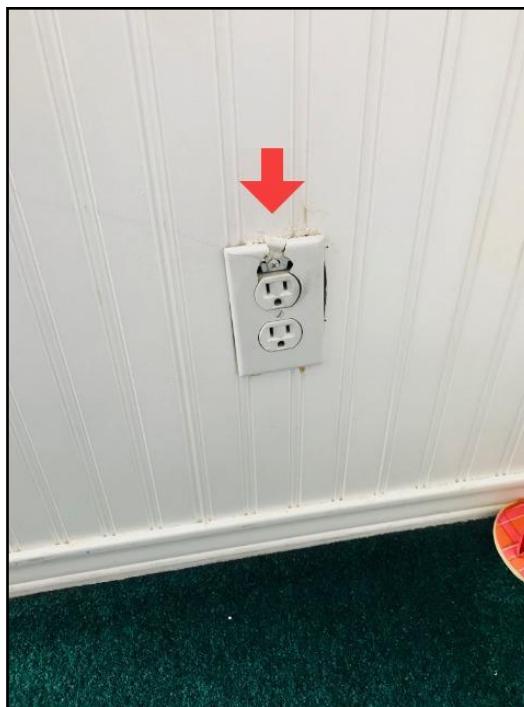
**6. Electrical • Distribution system**

Condition: Outlets (receptacles) • Damage

Location: Second Floor Bedroom

Damaged outlet(s) noted. Recommend replacement.

Action: Replace

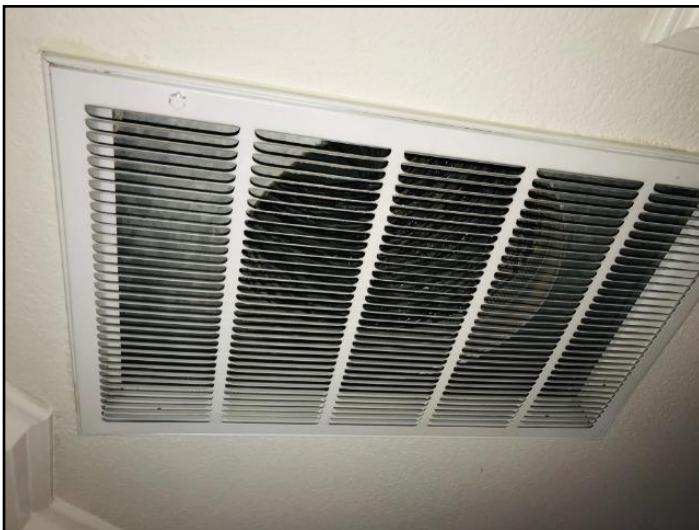
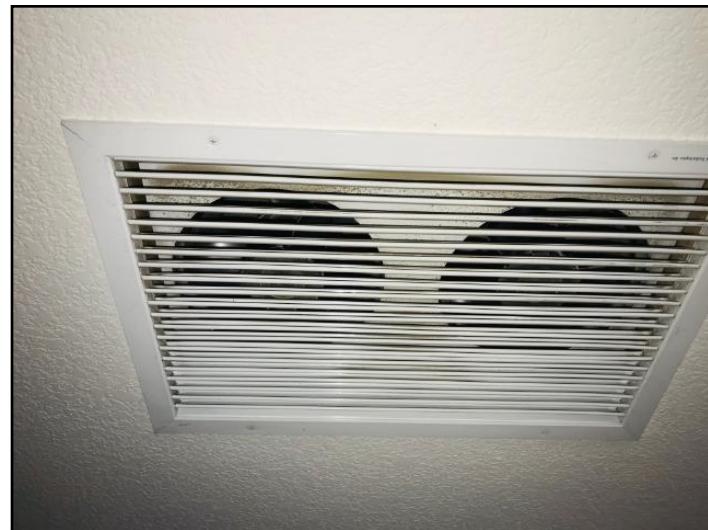
**7. Cooling & Heat Pump • Air conditioning**

Condition: Ducts, registers and grilles • Missing air filter

Location: Second Floor Hallway

Seller to provide Air Filter prior to close of Escrow.

Action: Replace

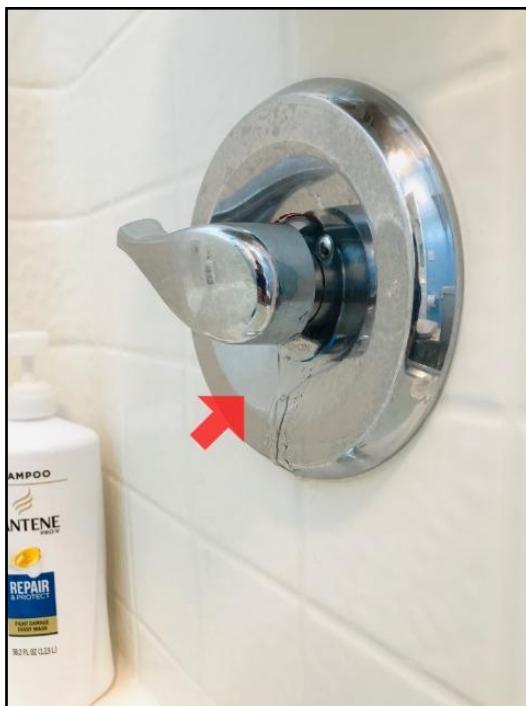
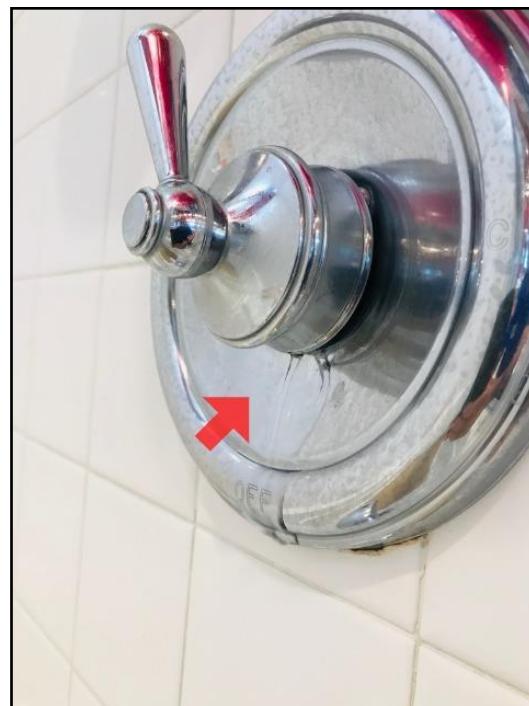
**8. Plumbing • Fixtures and faucets**

Condition: Faucet • Drip, leak

Location: Second Floor Master Bathroom, Hallway Bathroom

Leaks noted at shower knob(s). Recommend repairs by a qualified plumbing specialist.

Seller to repair prior close of Escrow.

Action: Repair

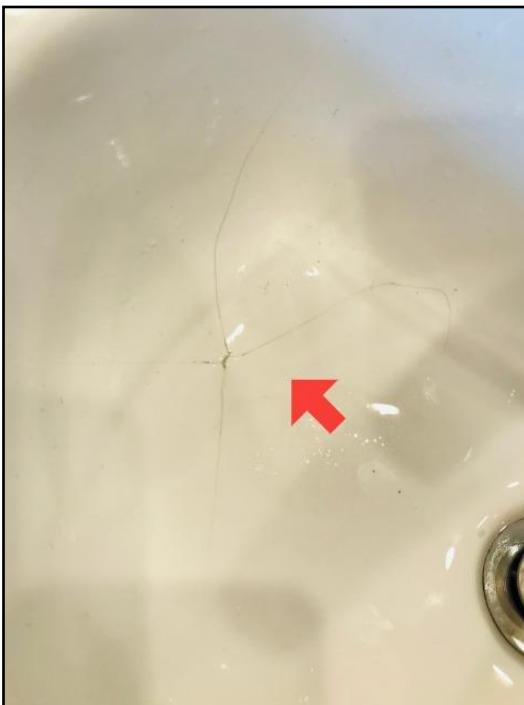
**9. Plumbing • Fixtures and faucets**

Condition: Basin, sink and laundry tub • Surface defects

Location: Second Floor Master Bathroom

Cracks noted to sink. Recommend repairs and/or replacement to prevent water leaks.

Action: Replace

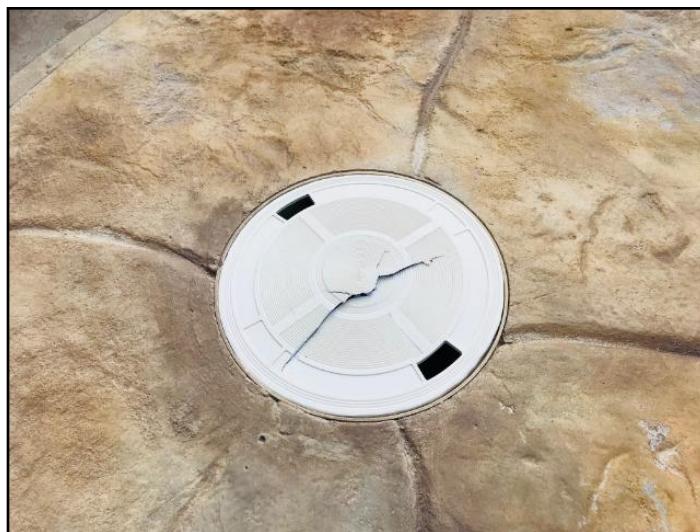
**10. Plumbing • Pool / Spa / Hot Tub**

Condition: General

Location: Exterior Pool

Damaged pool skimmer cover.

Action: Replace

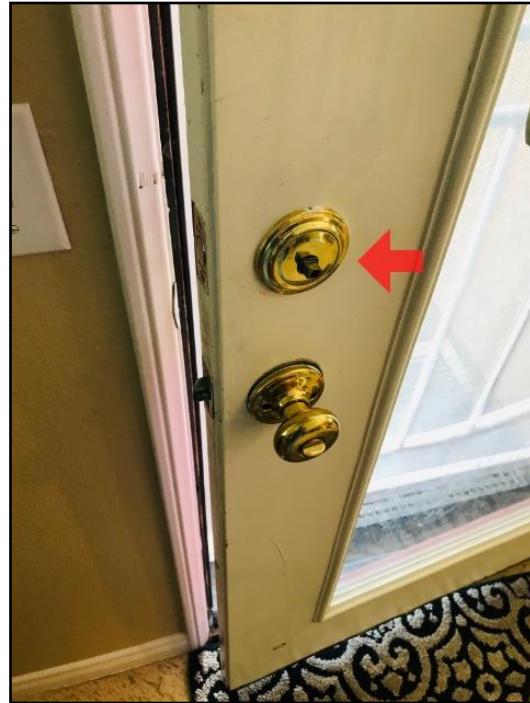
**11. Interior • Doors**

Condition: Hardware • Broken

Location: Family Room

Damaged door locking mechanism noted.

Action: Repair

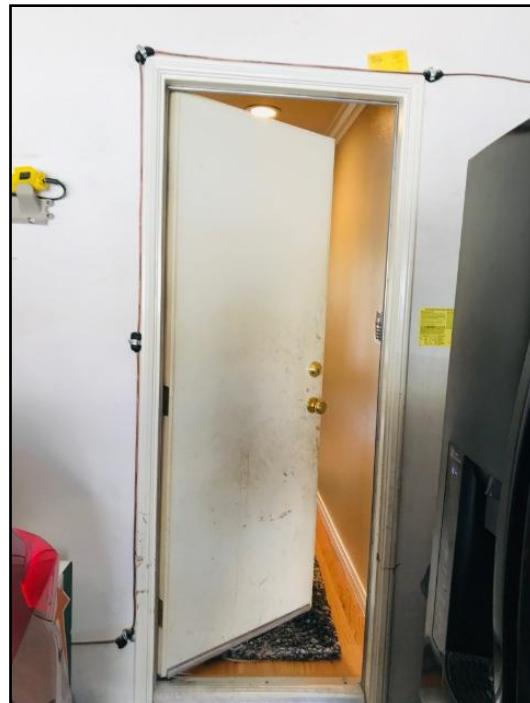
**12. Interior • Garage**

Condition: Door between garage and living space • Does not close door fully

Location: Garage Hallway

Inoperative self-closer noted to door. Recommend repairs so that door always auto-closes to prevent fumes and/or carbon monoxide from entering the home.

Action: Repair
