# INSPECTION REPORT

CHATSWORTH, CA 91311

Inspection Date: Friday, June 9, 2017

RE: Report No. 1117, v.2

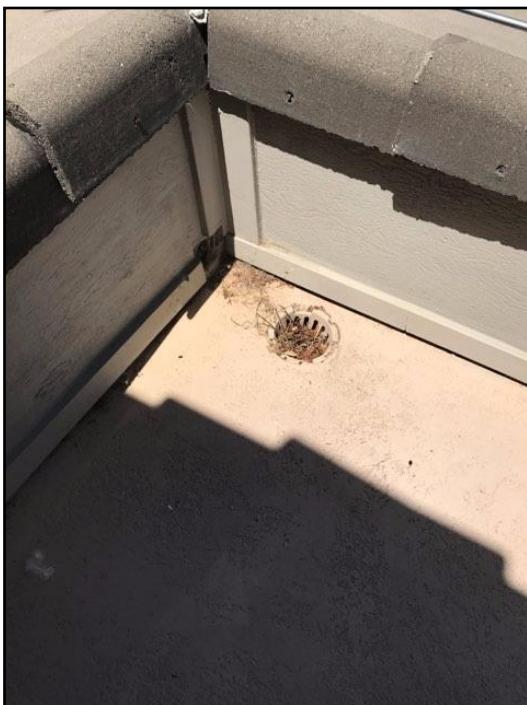
Debris noted to surface drains. Recommend cleaning, removal of debris for proper and adequate drainage.

1. Clogged

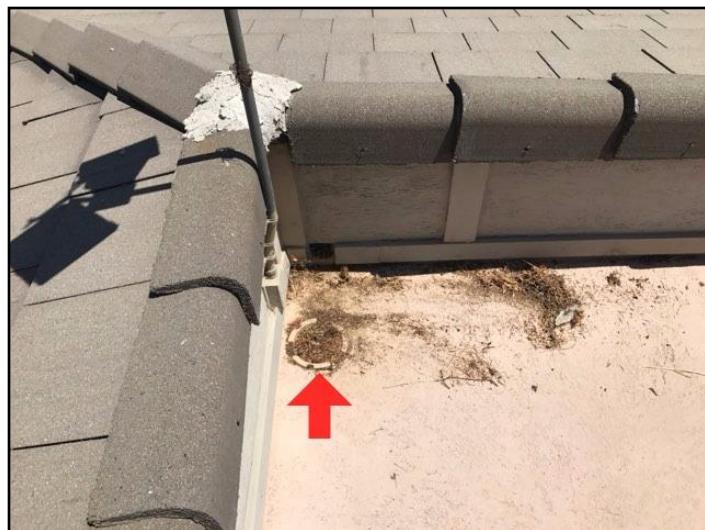
2. Clogged

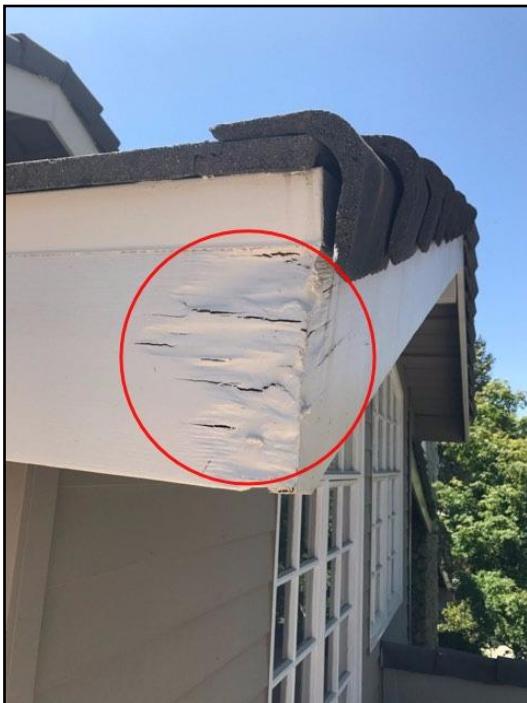
Signs of deterioration, dry rot, possible insect damage was noted. Recommend further evaluation by a licensed specialist.

5. Rot or insect damage

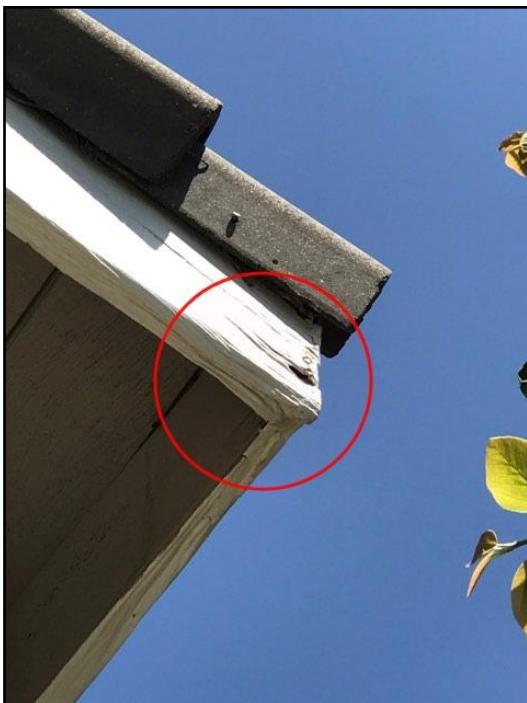
7. Rot or insect damage

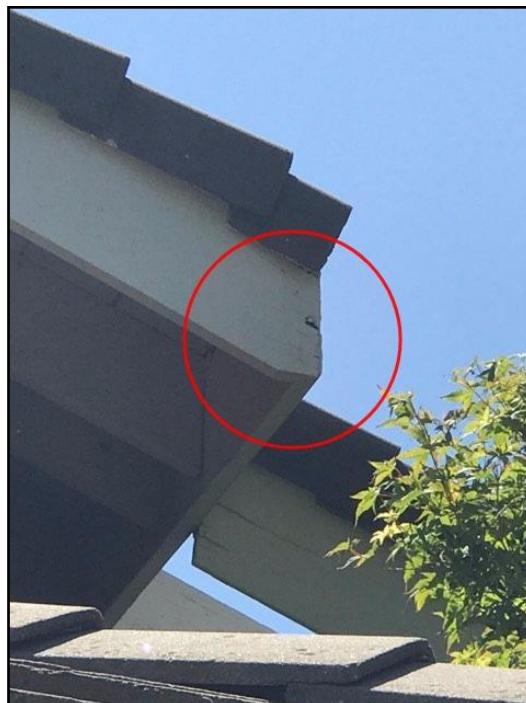
8. Rot or insect damage

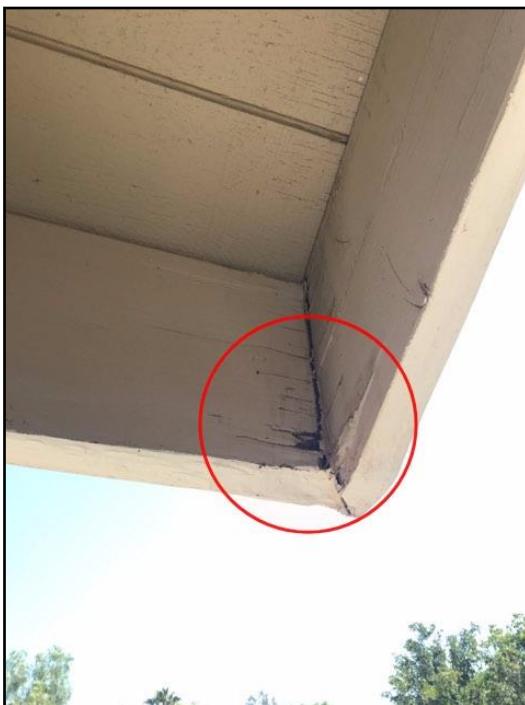
9. Rot or insect damage

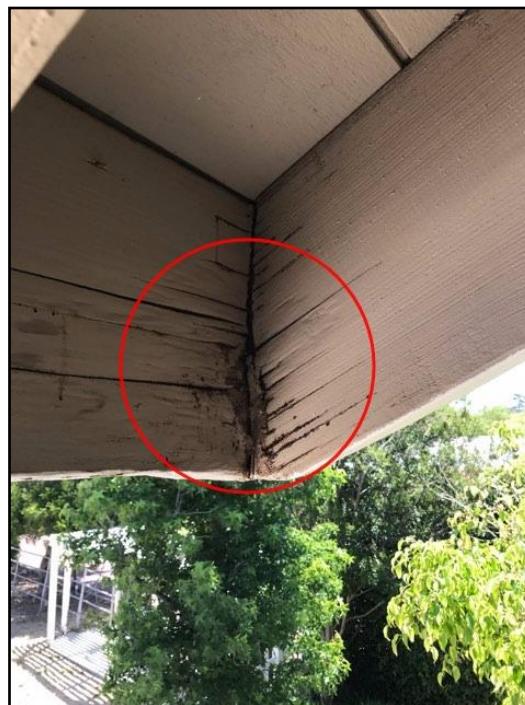
10. Rot or insect damage

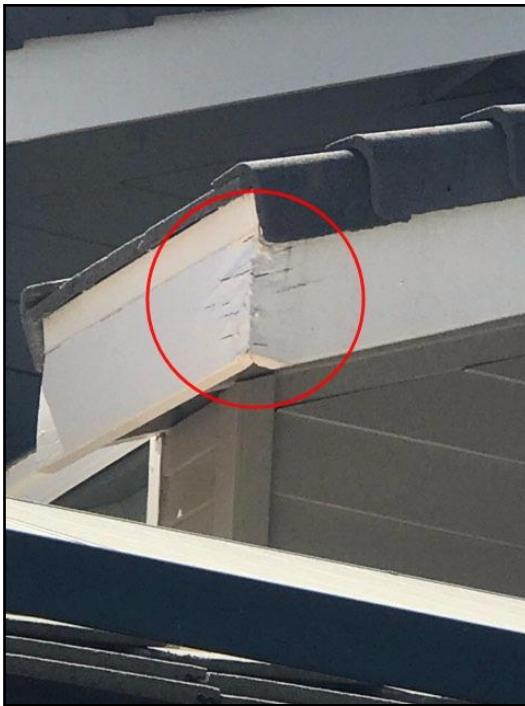
11. Rot or insect damage

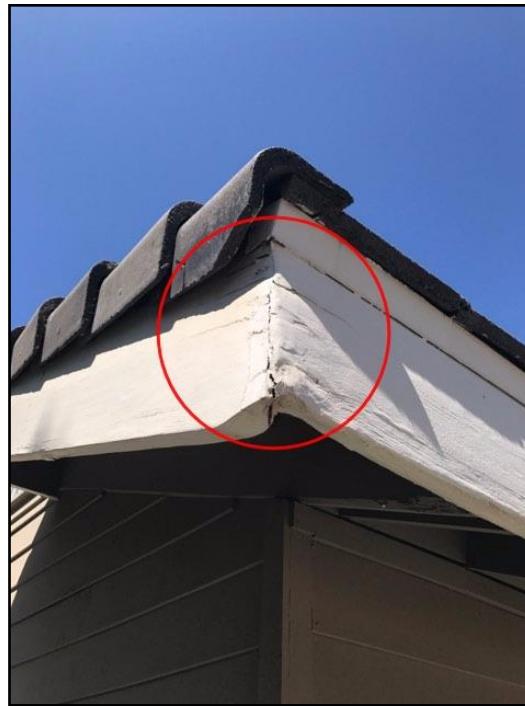
12. Rot or insect damage

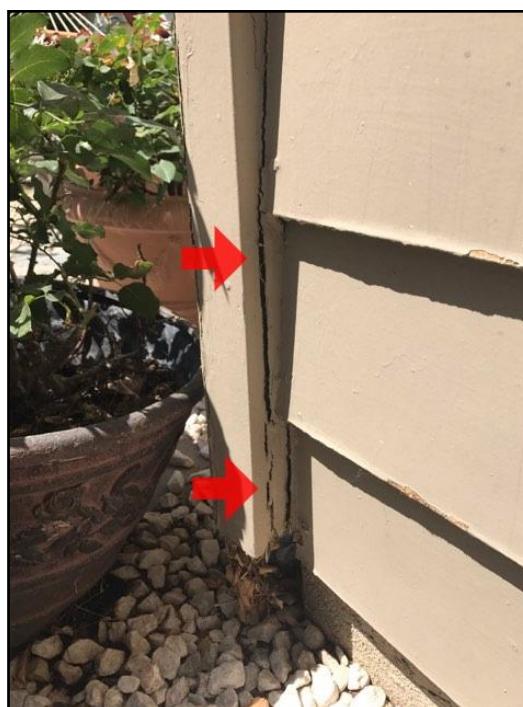
13. Rot or insect damage

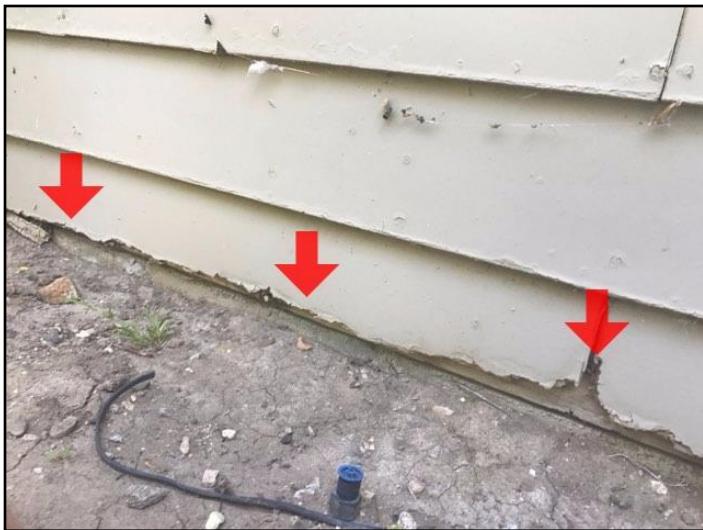
14. Rot or insect damage

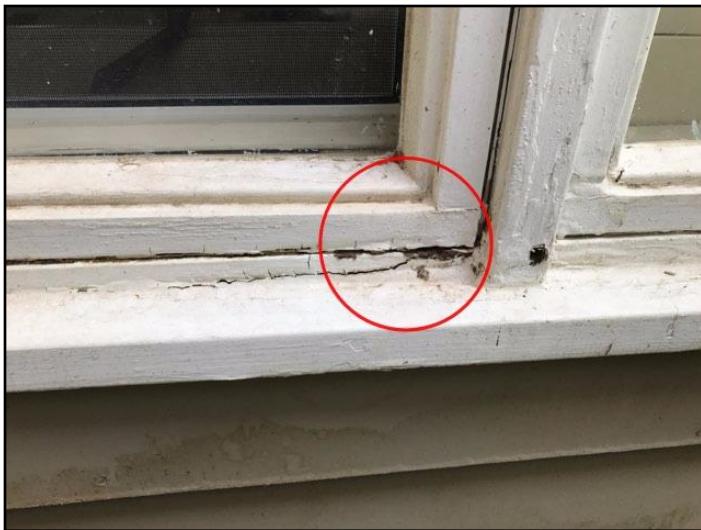
18. Rot or insect damage

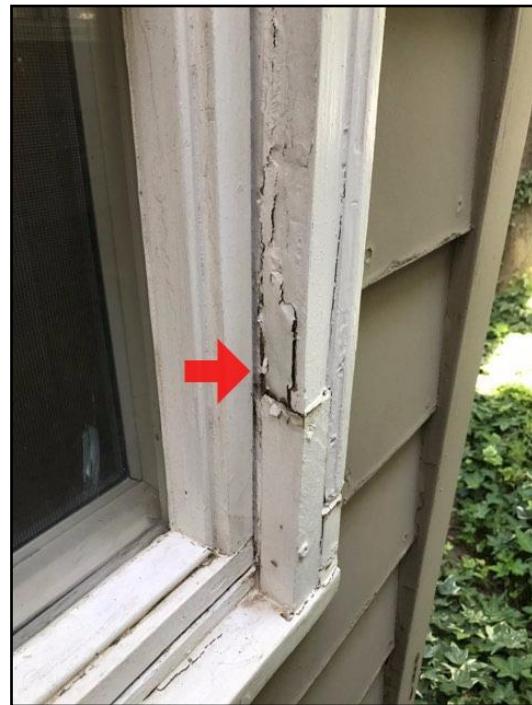
19. Rot or insect damage

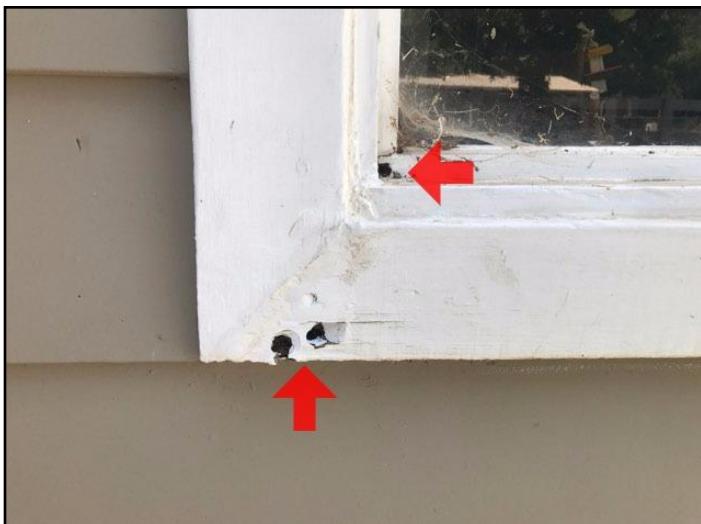
20. Rot or insect damage

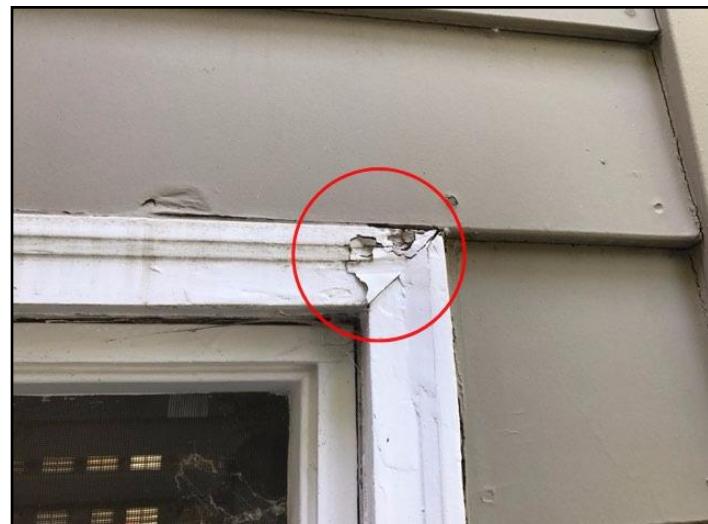
21. Rot or insect damage

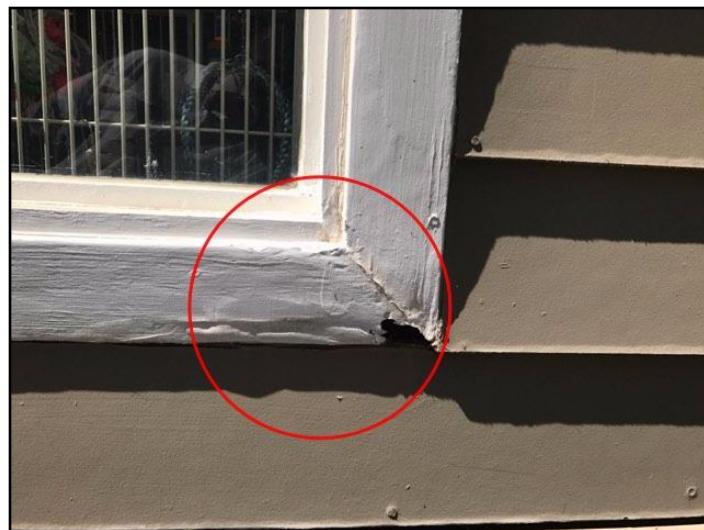
22. Rot or insect damage

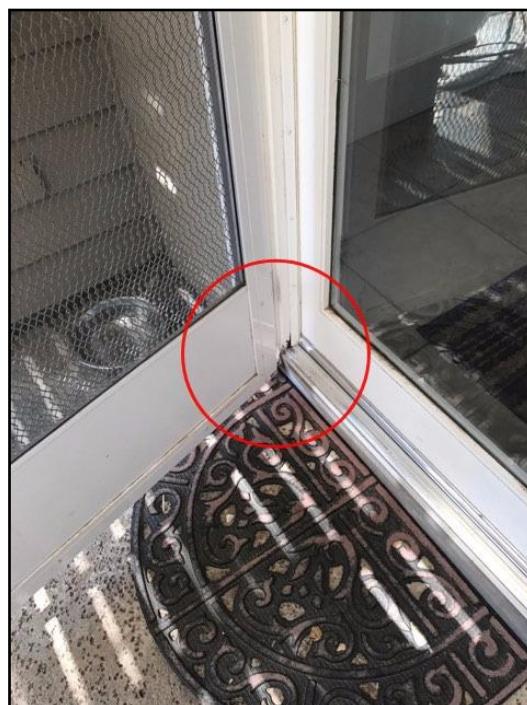
26. Rot or insect damage

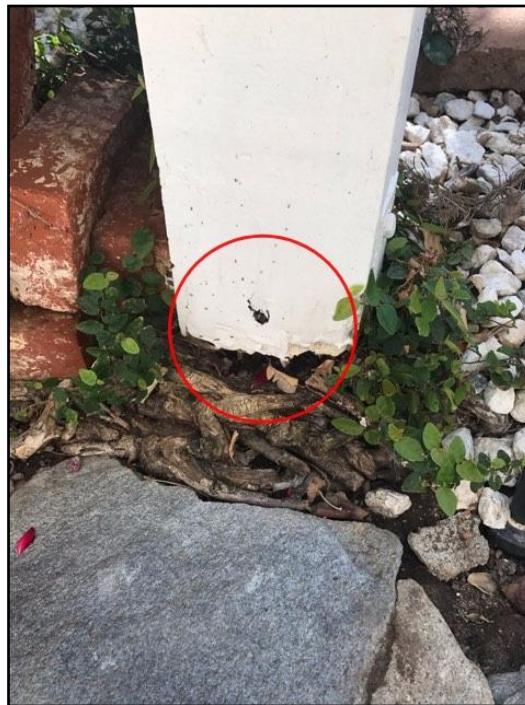
27. Rot

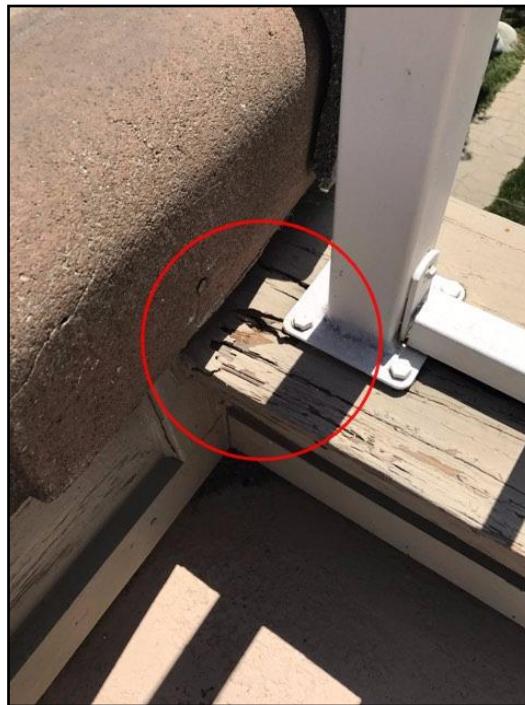
28. Rot or insect damage

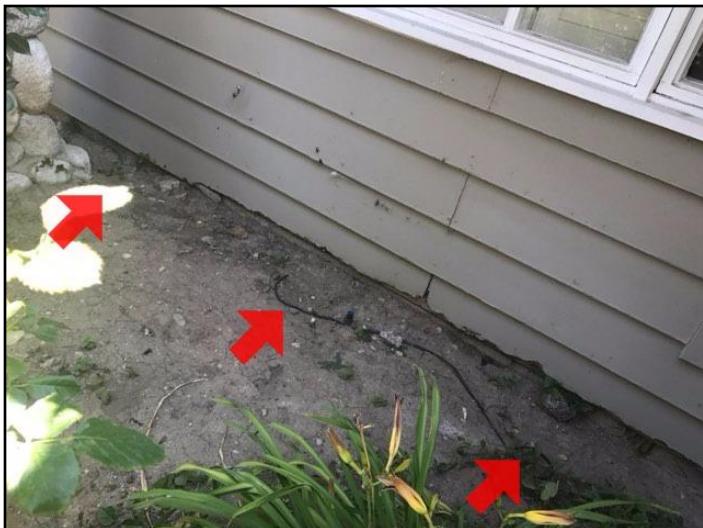
29. Improper slope or drainage

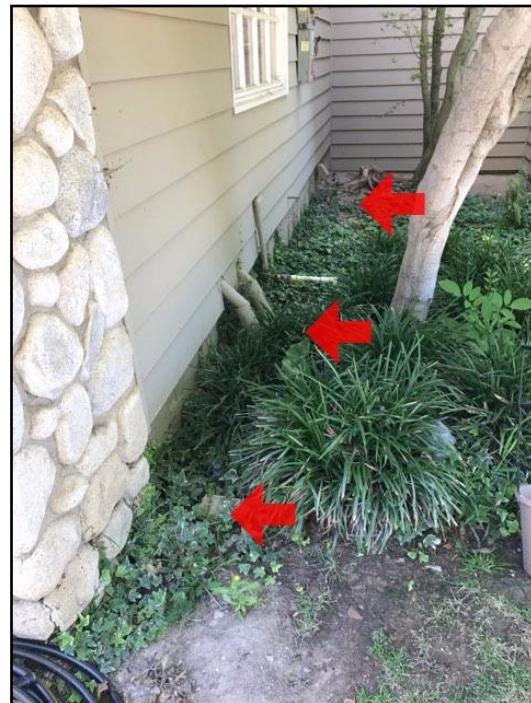
30. Improper slope or drainage

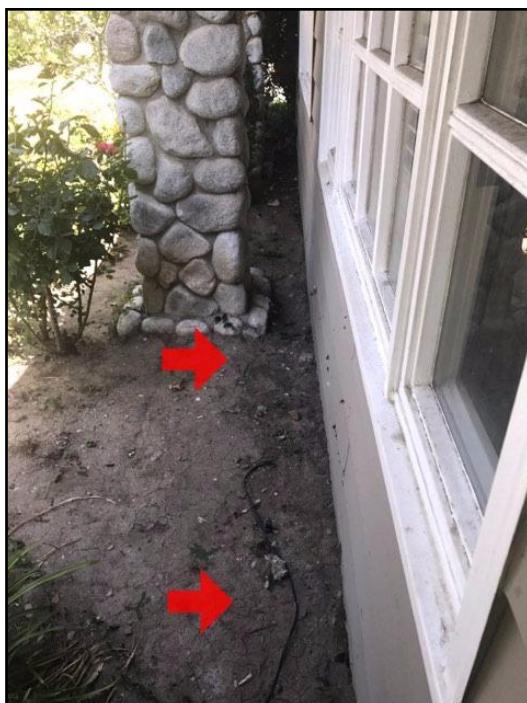
31. Improper slope or drainage

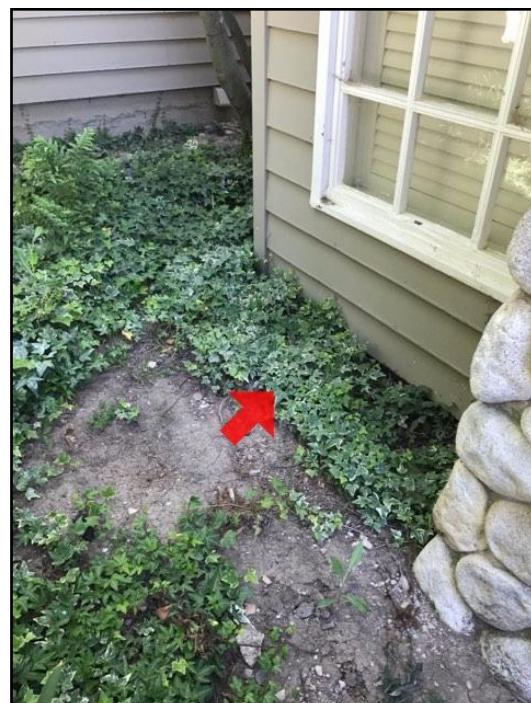
32. Improper slope or drainage

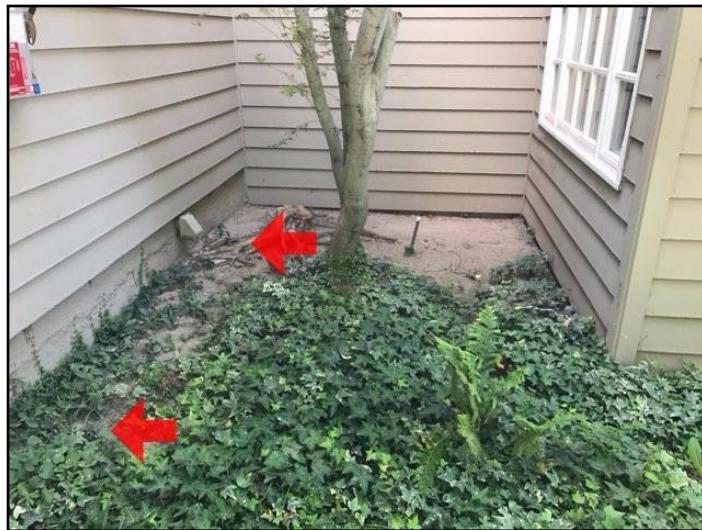
33. Improper slope or drainage

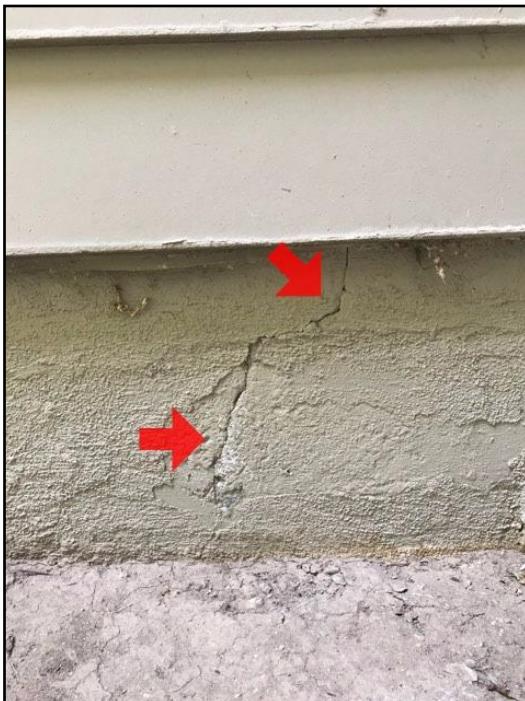
34. Cracked

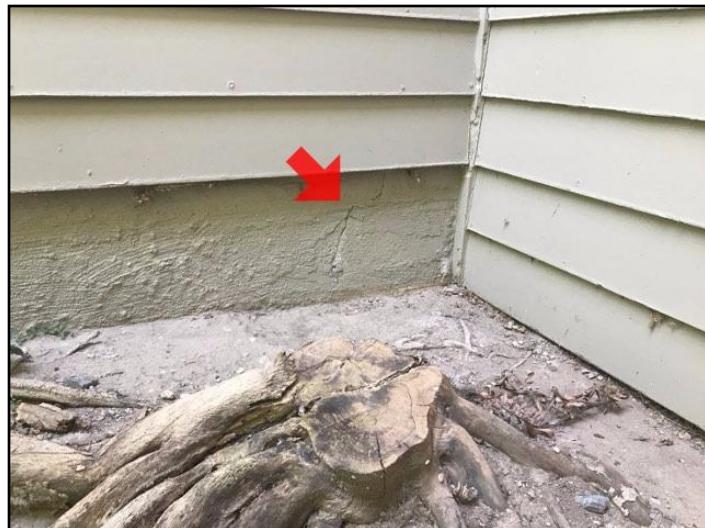
35. Cracked

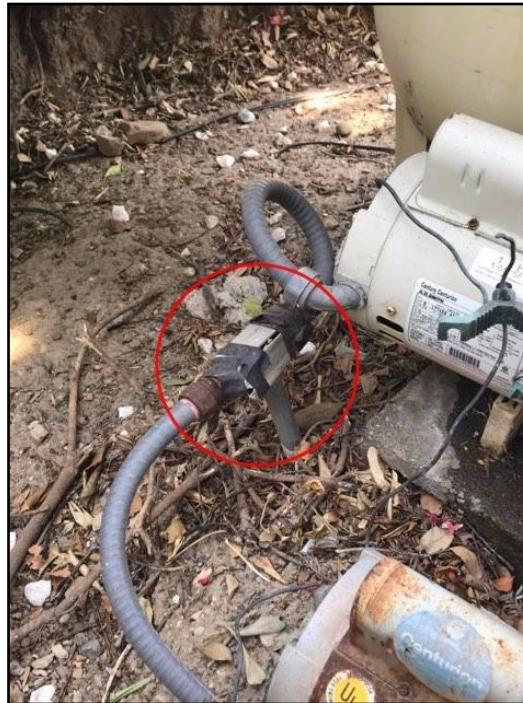
39. Missing, loose

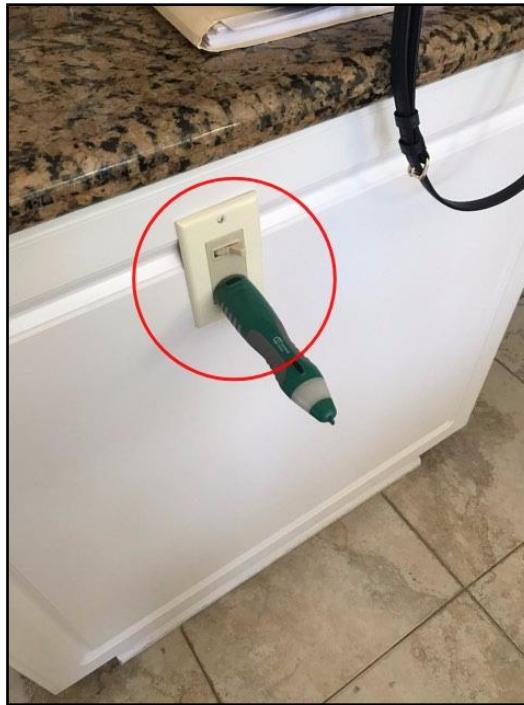
40. *Inoperative*

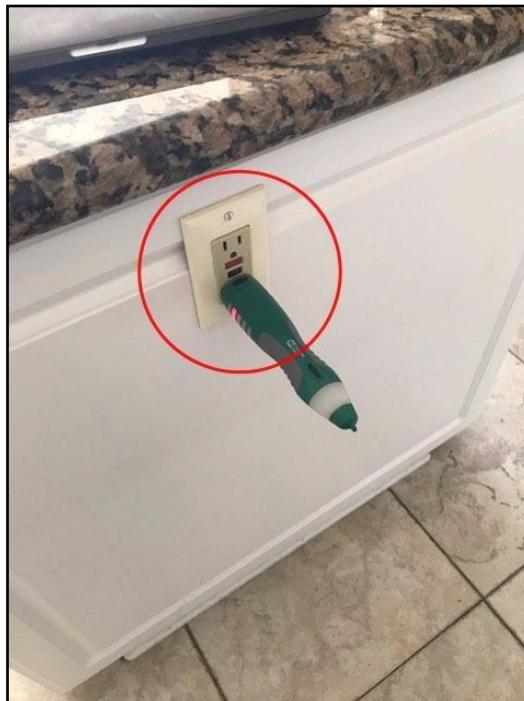
41. Ungrounded

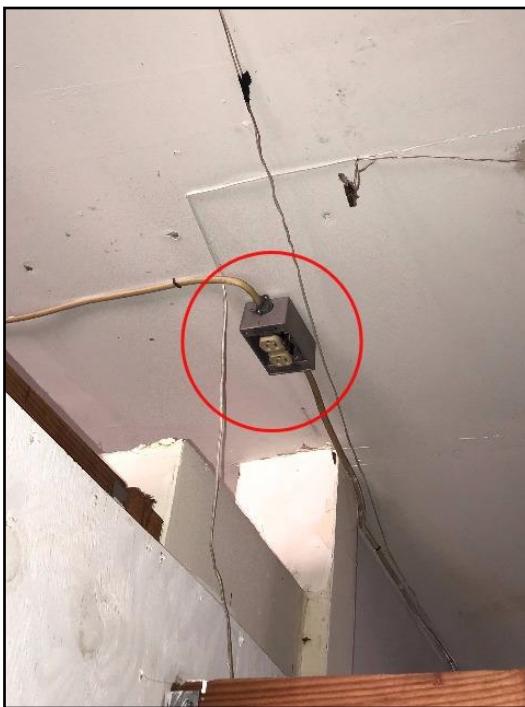
42. Missing

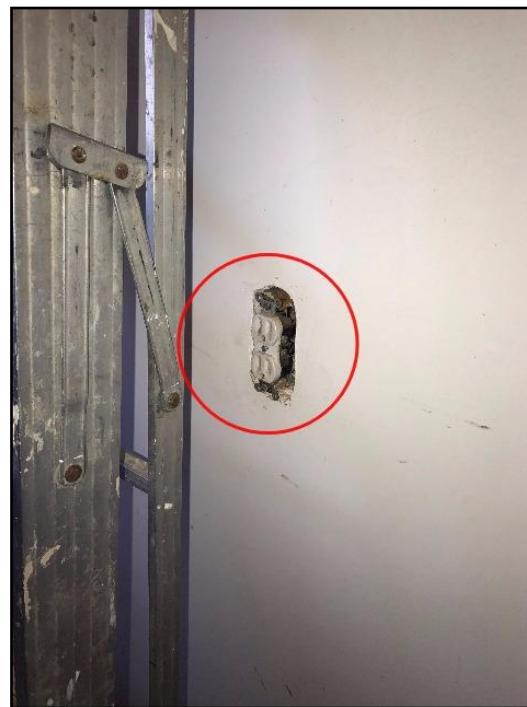
43. Missing

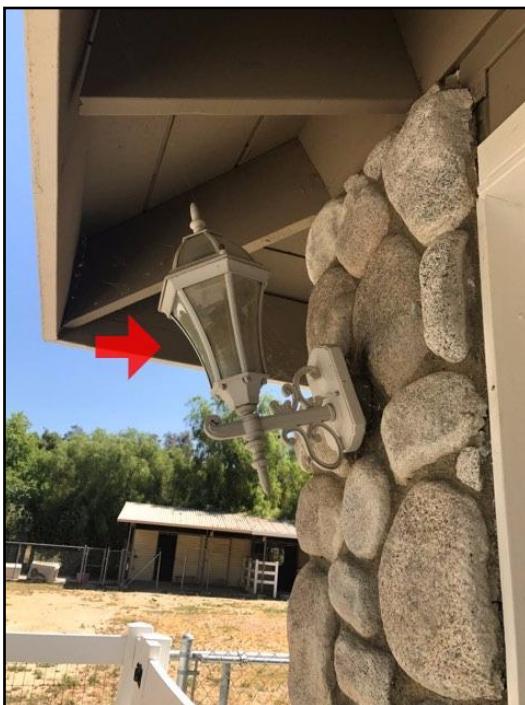
44. Loose

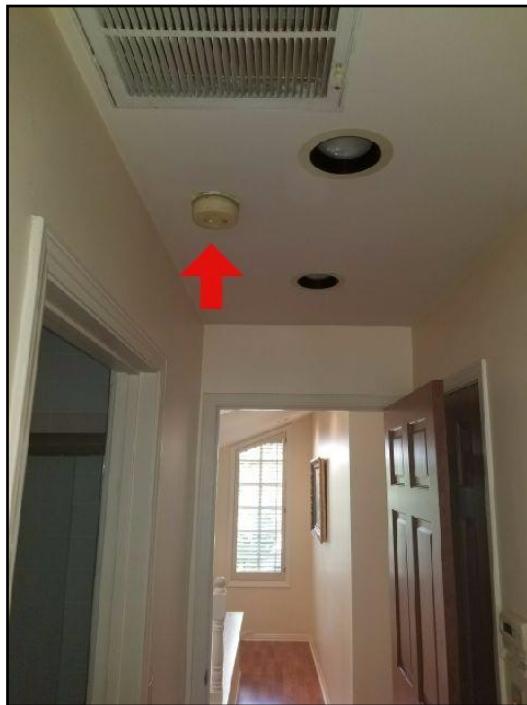
**Condition:** • Inoperative

Non functional smoke alarm noted. Recommend repairs and/or replacement.

**Implication(s):** Fire hazard

46. Inoperative

**Task:** Replace

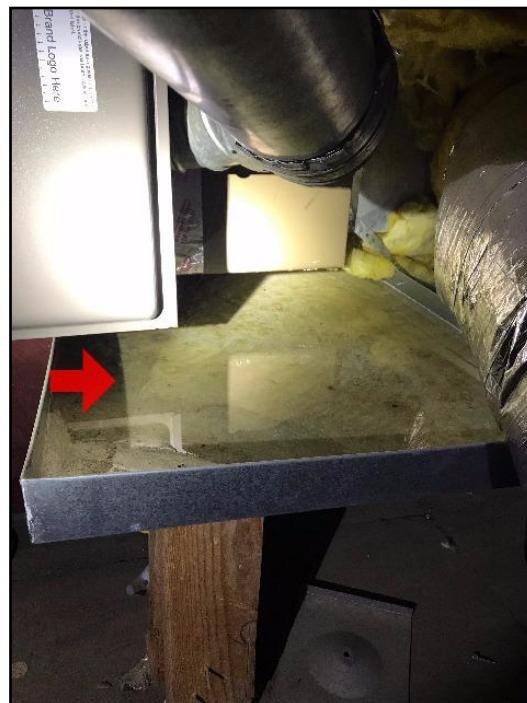
**Condition:** • [Pan overflowing](#)

Water pooling was noted at drip pan. Signs of poor drainage at condensation drain pipes. A licensed HVAC specialist is recommended to further evaluate.

**Implication(s):** Chance of water damage to contents, finishes and/or structure | Damage to equipment

**47. Pan overflowing****AIR CONDITIONING \ Refrigerant lines****Condition:** • Insulation - missing

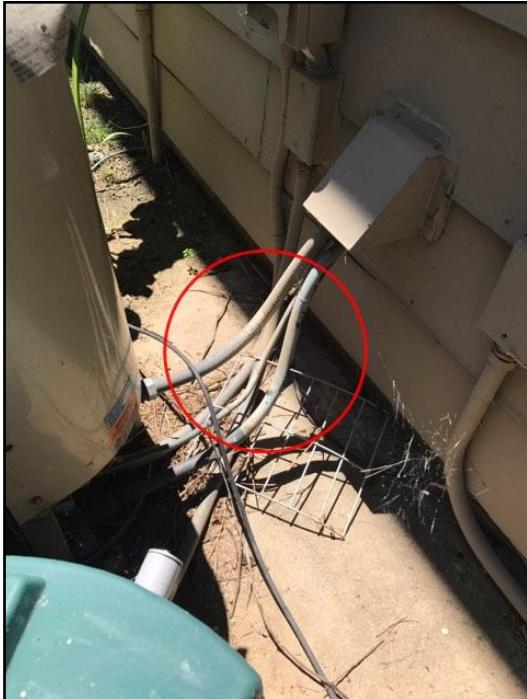
Missing insulation noted. Recommend installing insulation to prevent lines from freeze.

48. Insulation - missing

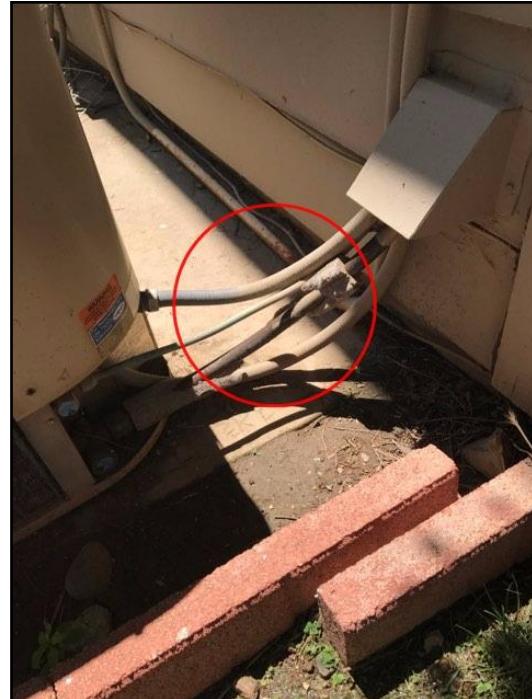
49. Insulation - missing

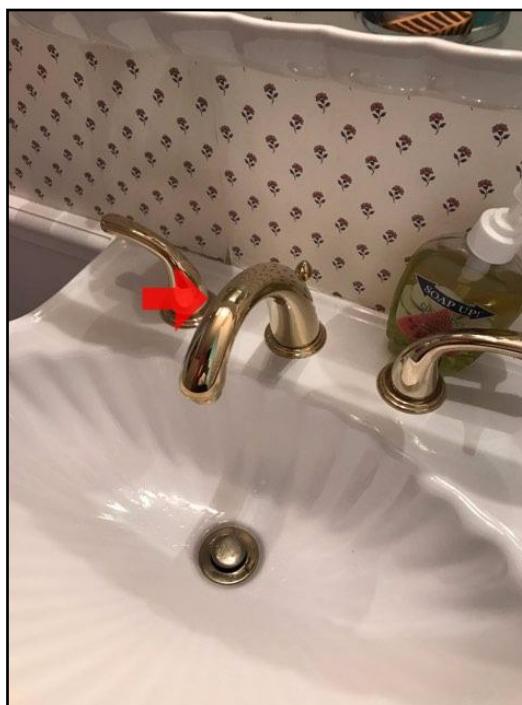
**Condition:** • Loose

Loose faucet noted.

**Implication(s):** Equipment failure

50. Loose

**Task:** Repair or replace

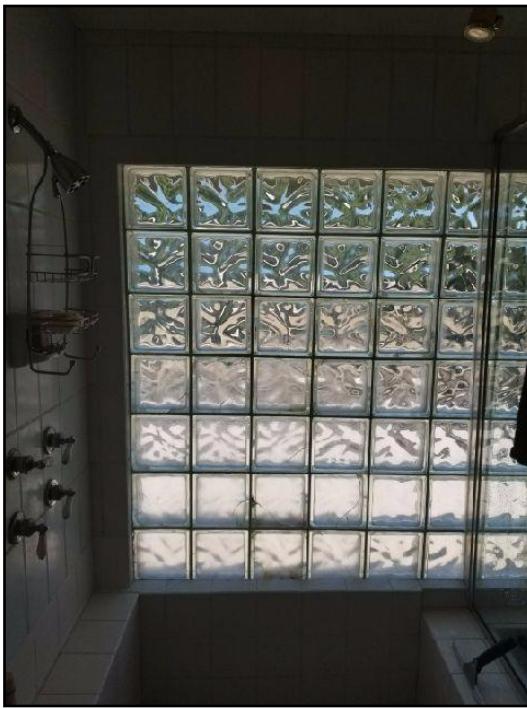
51.

**Condition:** • Cracked class noted. Recommend repairs and/or replacement.

**Task:** Replace

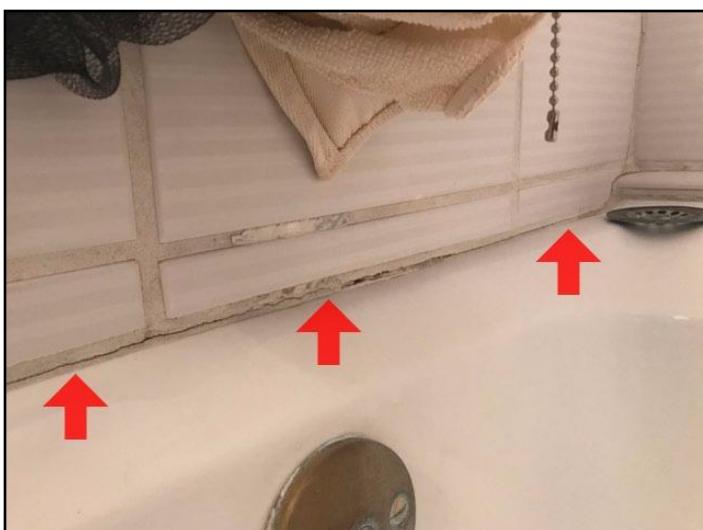
## Condition: • Grout loose, missing or deteriorated

Signs of missing caulking/grout noted. Suggest tub/shower edges, tiles be caulked and sealed to prevent moisture penetration. All missing, deteriorated/damaged caulking, grouting should be replaced, Failure to keep tub shower edges sealed can potentially cause deterioration and extensive moisture damage to the interior walls and surrounding sub-flooring. This damage is not always visible or accessible to the inspector at the time of the inspection.

**Implication(s):** Chance of water damage to contents, finishes and/or structure

53. Grout loose, missing or deteriorated

**Task:** Repair

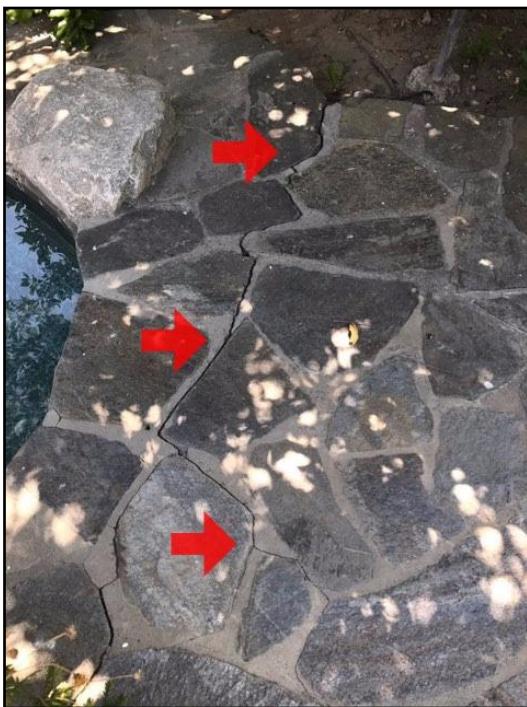
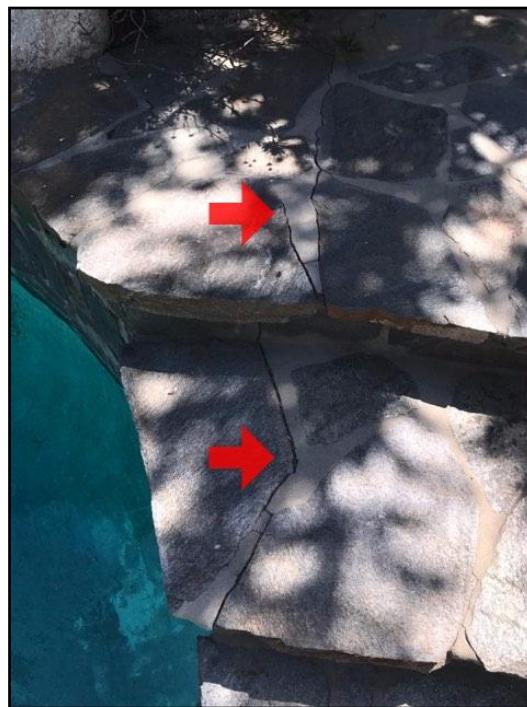
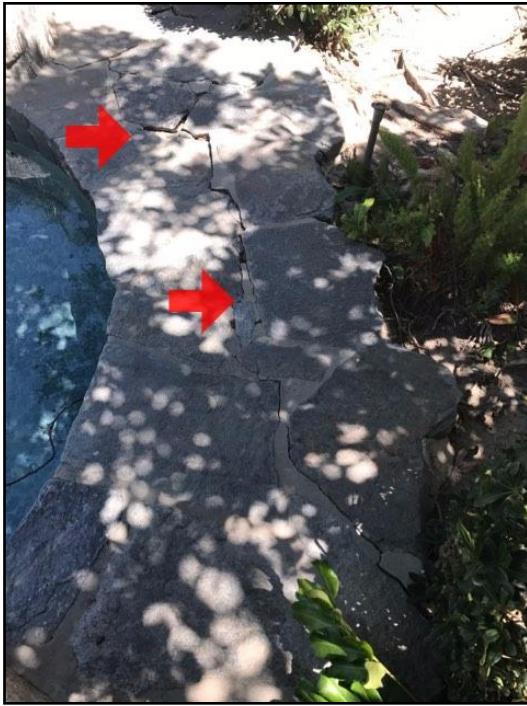
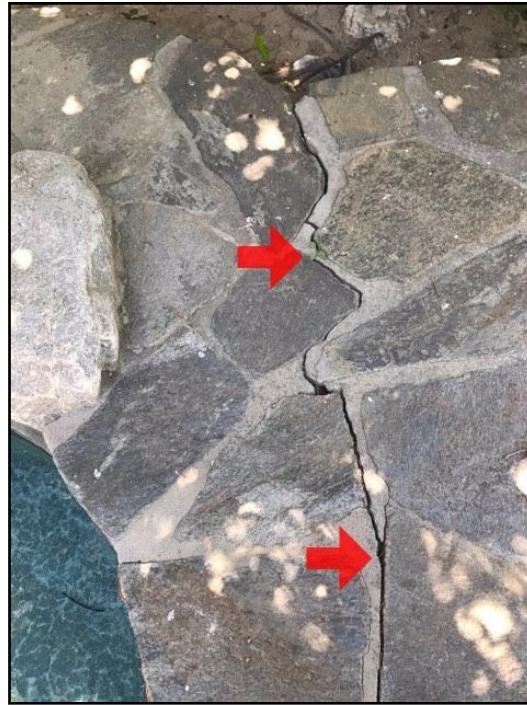
### Condition: • Surrounding deck/concrete cracked

Cracks were noted to concrete pool deck. Recommend sealing cracks to prevent from further expansion. If requested, a licensed specialist may be recommended to further evaluate.

**Implication(s):** Material deterioration | Equipment not operating properly | Physical injury

56. Surrounding deck/concrete cracked

57. Surrounding deck/concrete cracked

58. Surrounding deck/concrete cracked

59. Surrounding deck/concrete cracked

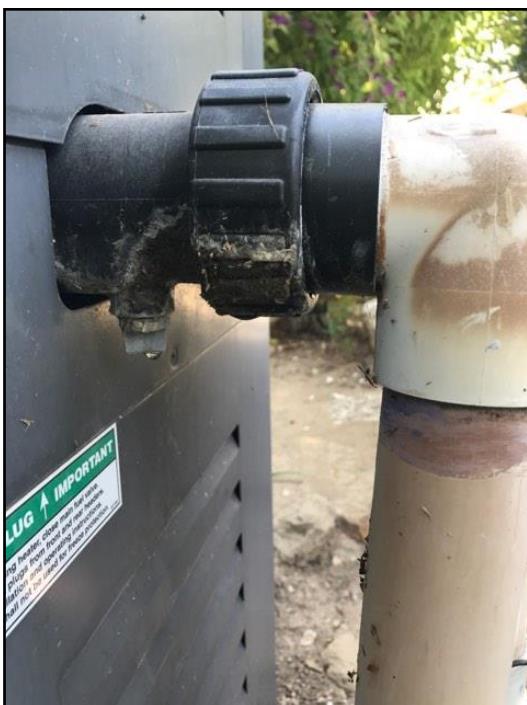
Condition: • Pump leaking

Leak noted at pool pump. A licensed pool specialist is recommended to further evaluate.

60. Pump leaking

**Task:** Repair

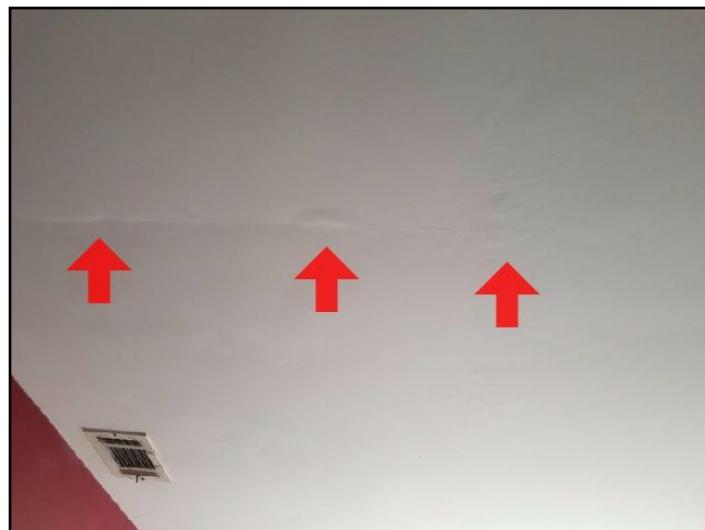
- Water stains

Ceiling was observed and evidence of deterioration/bubbling surface was noted. A licensed specialist may be recommended to further evaluate.

65. Water stains

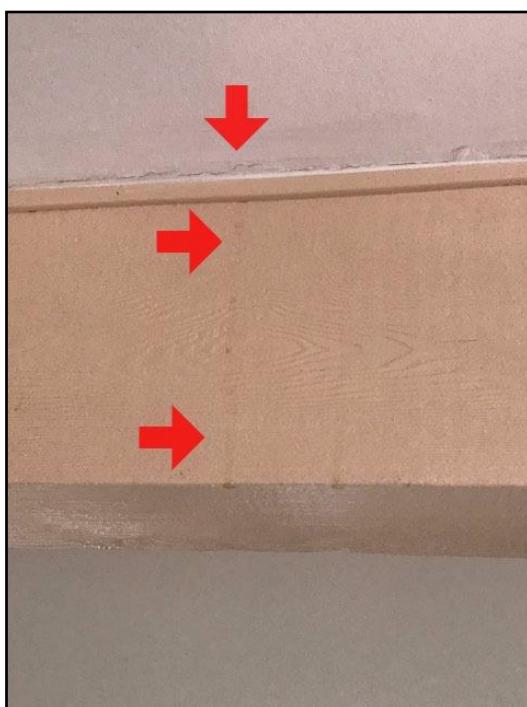
**Condition:** • Water stains

Signs of water stains, deterioration was noted. Recommend further evaluation by a licensed specialist. Recommend seller disclose.

66. Water stains

**Task:** Further evaluation

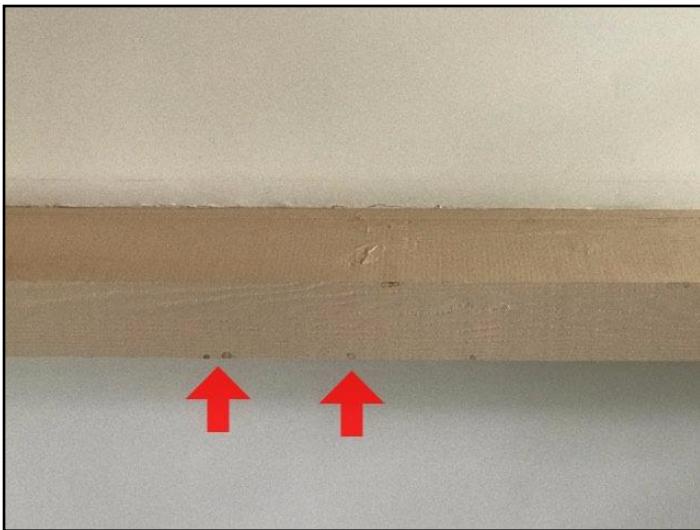
68. Water stains

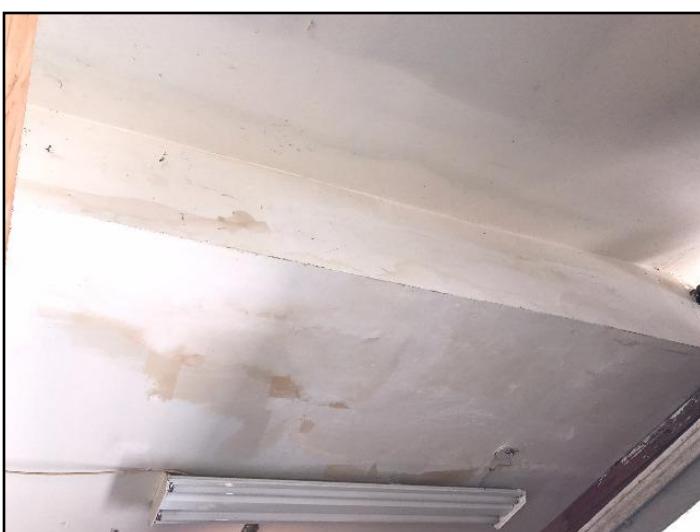
**Condition:** • Water stains

Signs of water stains was noted to ceiling. Master bathroom at 2nd floor is above the area where the moisture stains were noted. Recommend further evaluation by a licensed specialist. Recommend seller disclose.

70. Water stains

**Task:** Monitor Request disclosure

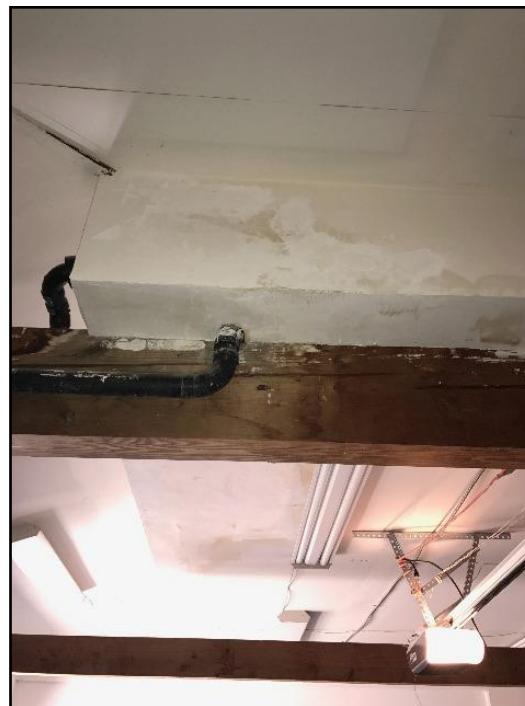
72. Water stains

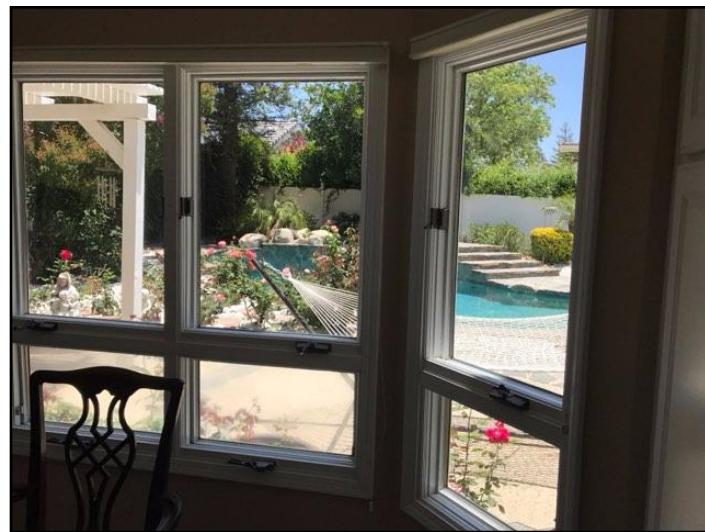
**Condition:** • Difficult to operate

Difficult to operate. Hard operation was noted to window. Recommend repairs for ease of operation.

74. Difficult to operate

**Task:** Improve, Correct

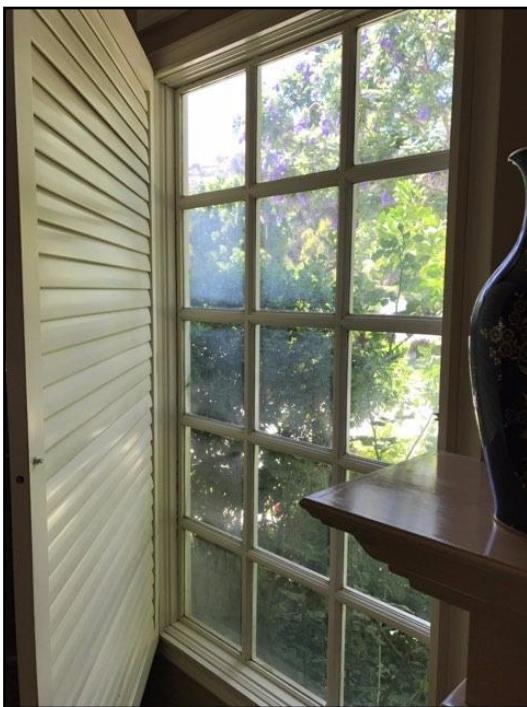
75.

**Condition:** • Gaps noted. Recommended sealing and/or caulking.

**Task:** Correct

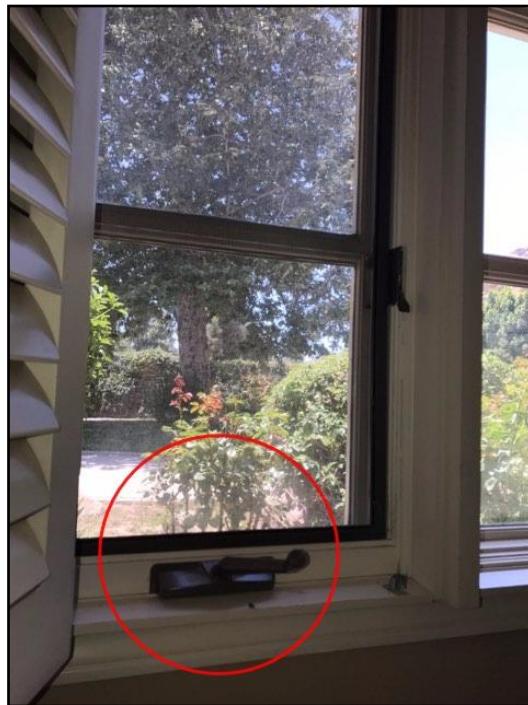
**WINDOWS \ Hardware****Condition:** • Inoperative

Inoperable windows noted. Recommend repairs for ease of operation.

**Implication(s):** System inoperative or difficult to operate**Location:** First Floor Living Room**Task:** Repair or replace**Time:** Immediate

77. Inoperative

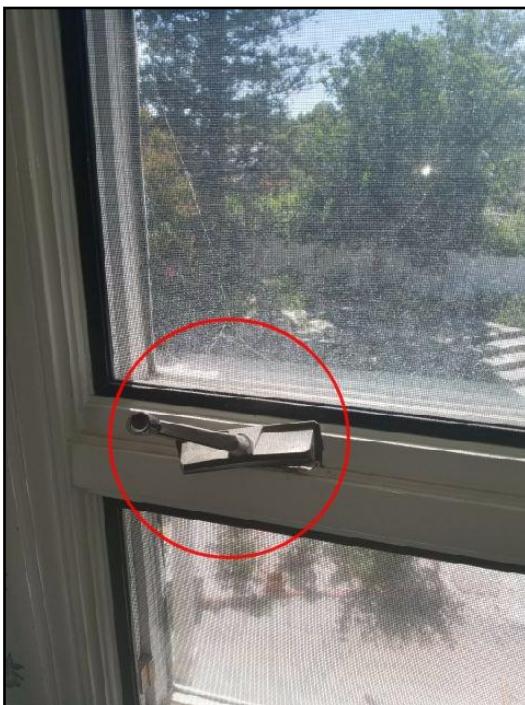
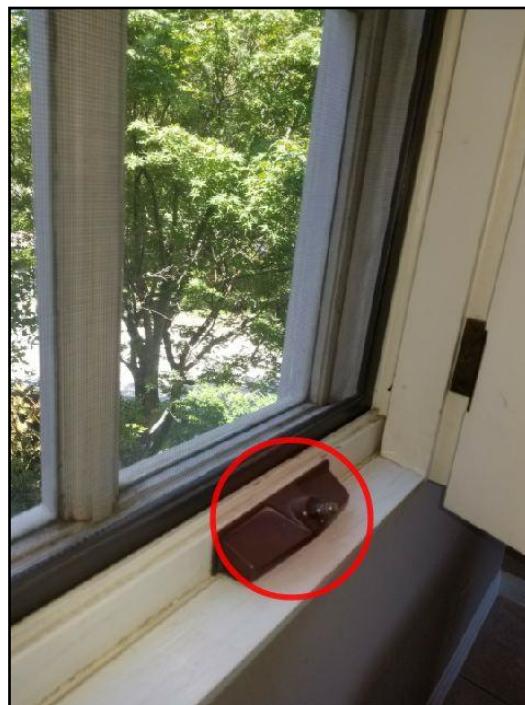
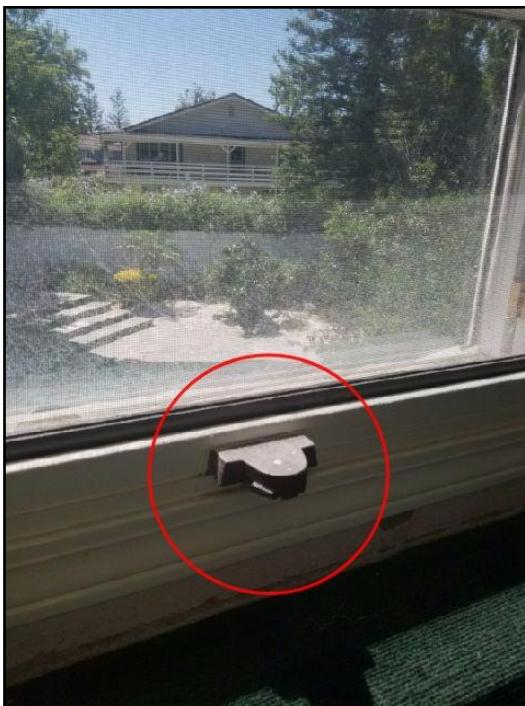
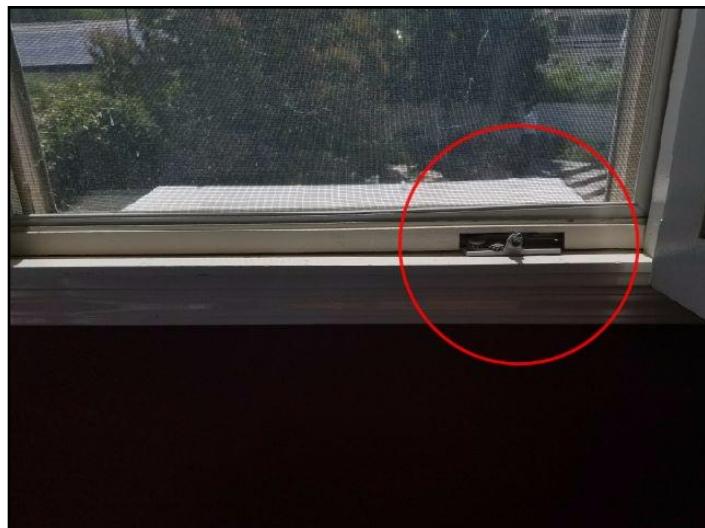
**Condition:** • [Inoperative](#)

Inoperative windows noted. Recommend repairs for ease of operation.

78. Inoperative

79. Inoperative

80. Inoperative

81. Inoperative

**Task:** Repair, Further evaluation

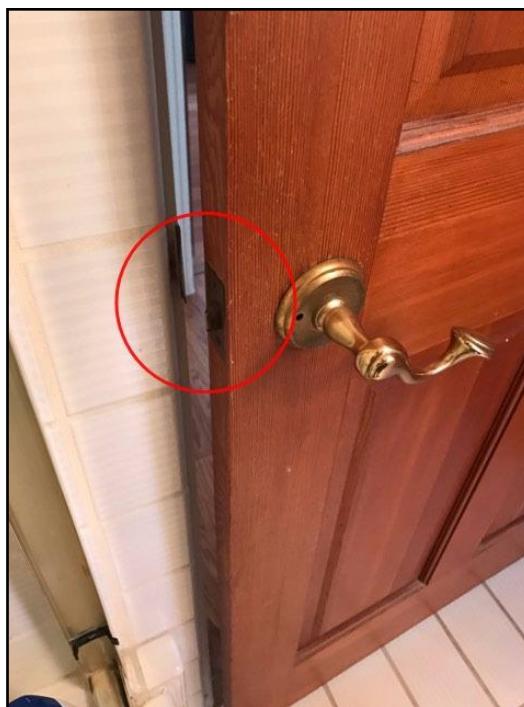
**Condition:** • Does not latch properly

Door locking mechanism was not fully functional. Locking mechanism does not latch. Recommend repairs.

82. Does not latch properly

**Task:** Repair

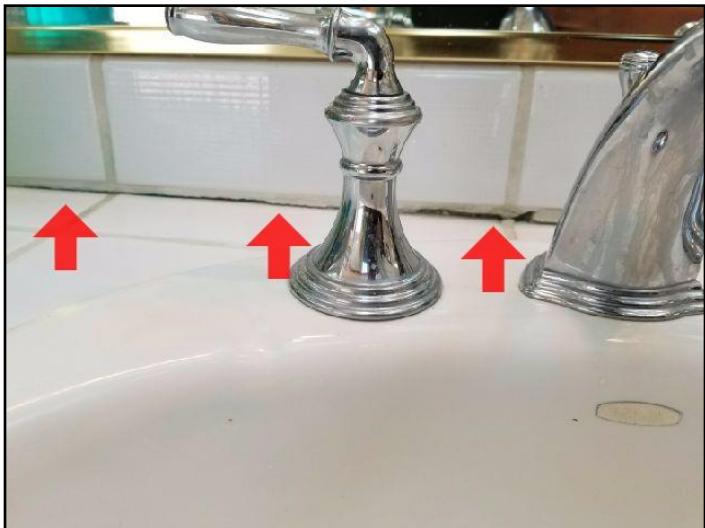
**Condition:** • [Grout loose or missing](#)

Missing grout noted. Recommend repairs to prevent deterioration to cabinet or walls from water moisture intrusion.

83. Grout loose or missing
