# INSPECTION REPORT

CHATSWORTH, CA 91311

Inspection Date: Friday, June 9, 2017

RE: Report No. 1117, v.2

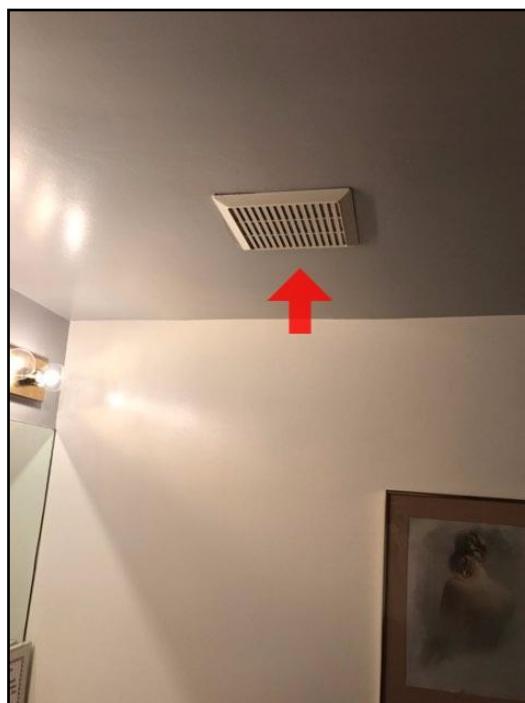
Condition: • Inoperative

Non functional exhaust fan noted.

Implication(s): Chance of condensation damage to finishes and/or structure

85. Inoperative

**Task:** Repair or replace

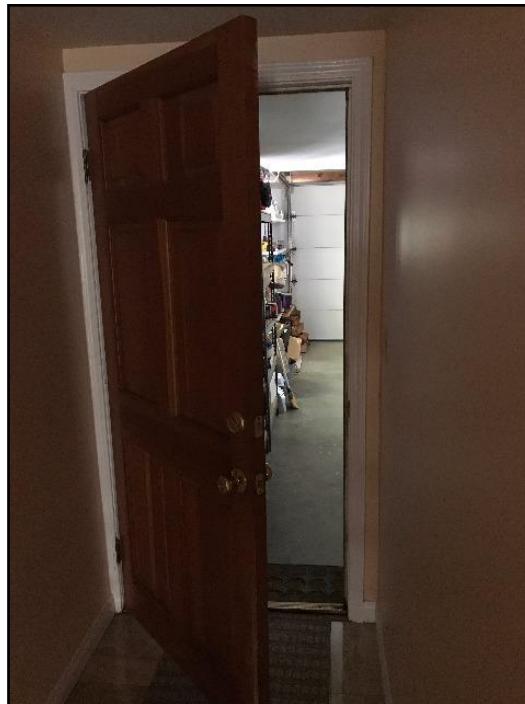
**Condition:** • No self closer

86. No self closer

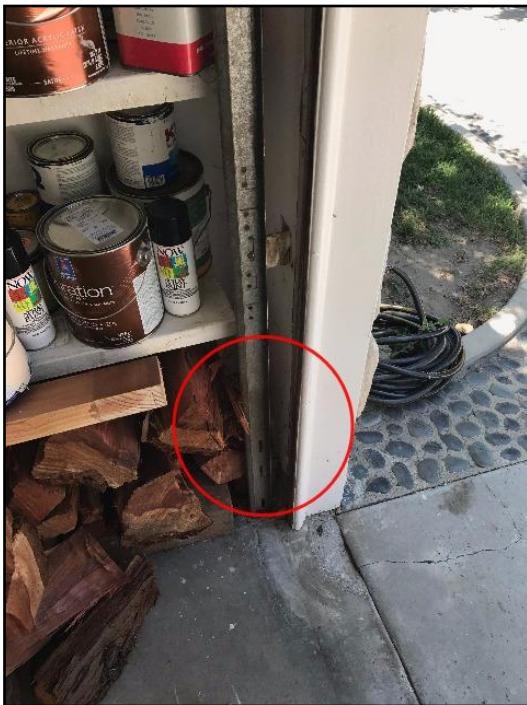
87. Sensors inoperative

**Task:** Provide

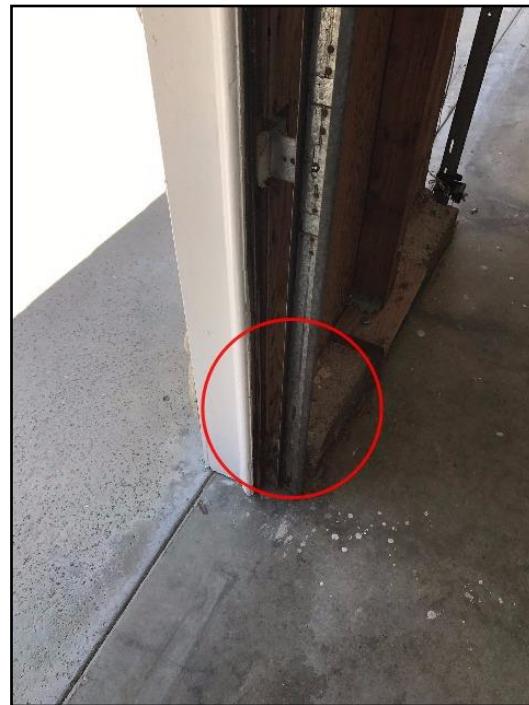
88. Sensors inoperative

Condition: • Sensors inoperative

No garage door sensors were present. This is considered a safety hazard and requires installation of sensors.

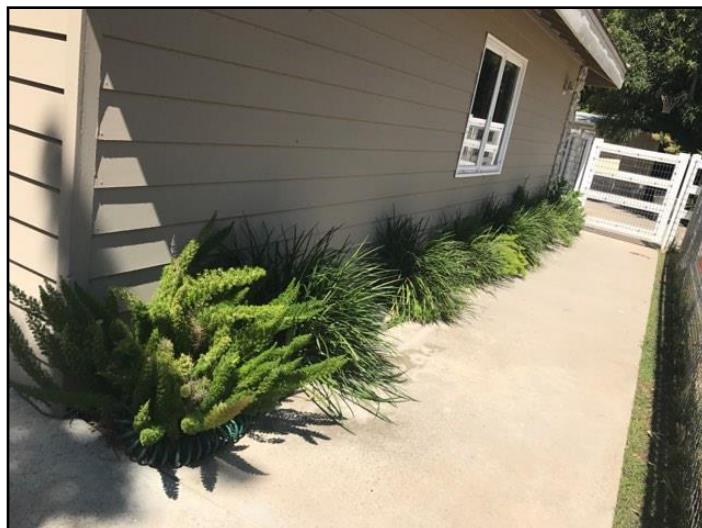
89. Vines/shrubs/trees against wall

**Inspection limited/prevented by:**

- Vines/shrubs/trees against wall

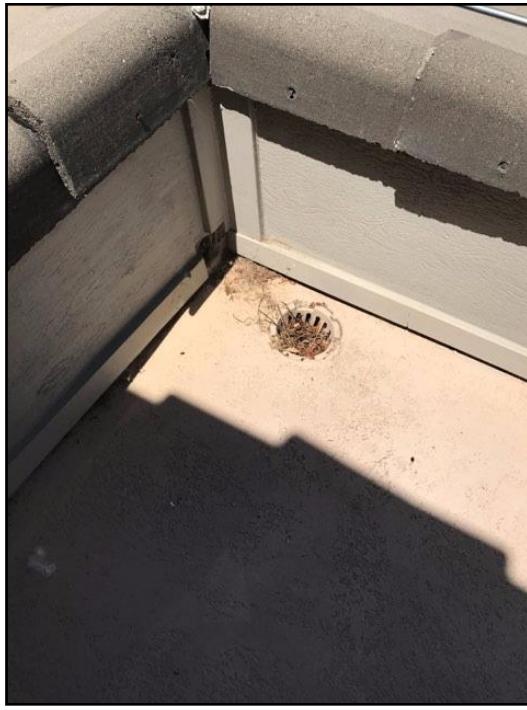
90. Clogged

**1. Condition:** • [Clogged](#)

Debris noted to surface drains. Recommend cleaning, removal of debris for proper and adequate drainage.

**Implication(s):** Chance of water damage to contents, finishes and/or structure

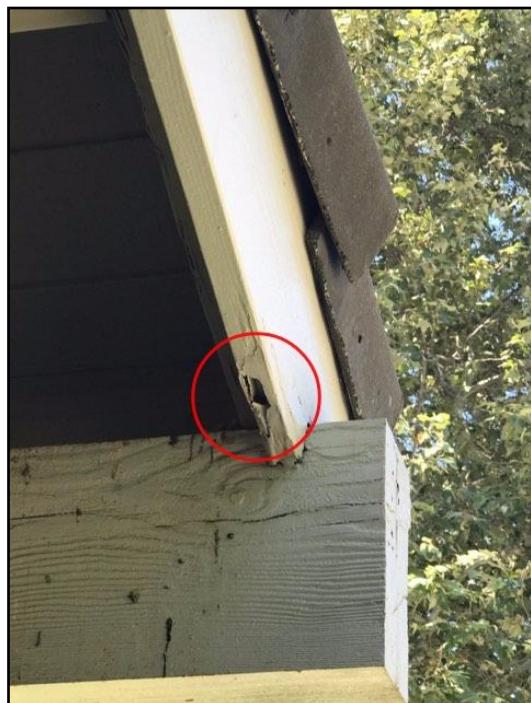
92. Rot or insect damage

### 2. Condition: • Rot or insect damage

Signs of deterioration, dry rot, possible insect damage was noted. Recommend further evaluation by a licensed specialist.

**Implication(s):** Chance of water damage to contents, finishes and/or structure | Material deterioration

**Task:** Repair or replace

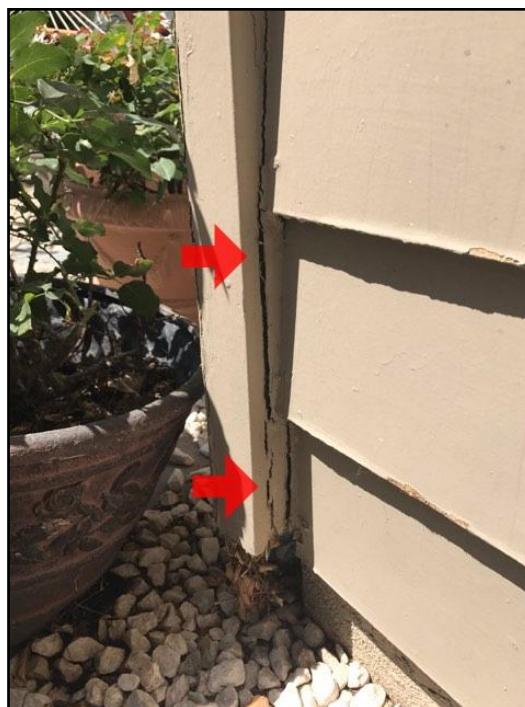
##### 3. Condition: • Rot or insect damage

Exterior trim was observed and evidence of deterioration, dry rot, possible insect damage was noted.

**Implication(s):** Chance of water damage to contents, finishes and/or structure | Material deterioration**Location:** Various Exterior Wall**Task:** Repair or replace**Time:** Immediate

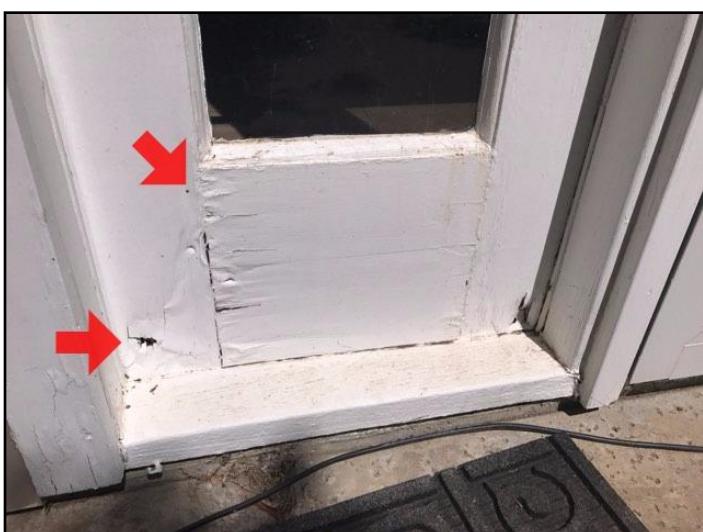
105. Rot or insect damage

**EXTERIOR GLASS/WINDOWS \ Frames****5. Condition:** • Rot or insect damage

Signs of deterioration, possible insect damage was noted to window wood trim. A licensed specialist is recommended to further evaluate.

**Implication(s):** Chance of water damage to contents, finishes and/or structure | Material deterioration

**Task:** Repair or replace

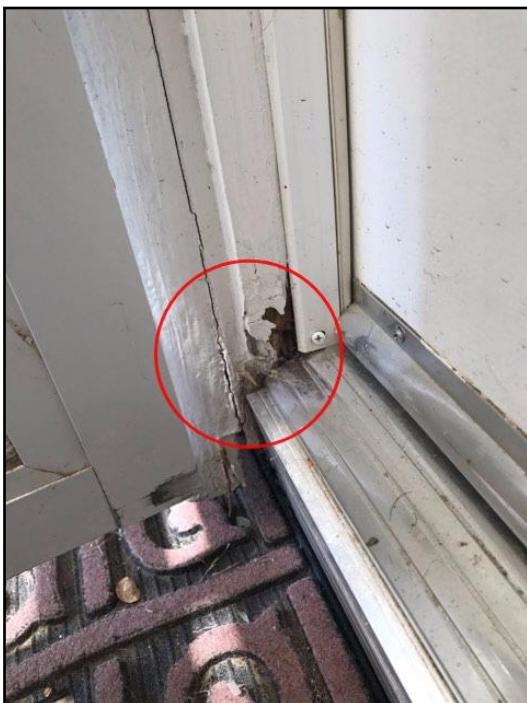
114. Rot or insect damage

## 7. Condition: • [Rot or insect damage](#)

Signs of deterioration, possible insect damage was noted to door frame.

**Implication(s):** Chance of damage to finishes and structure

**Task:** Repair or replace

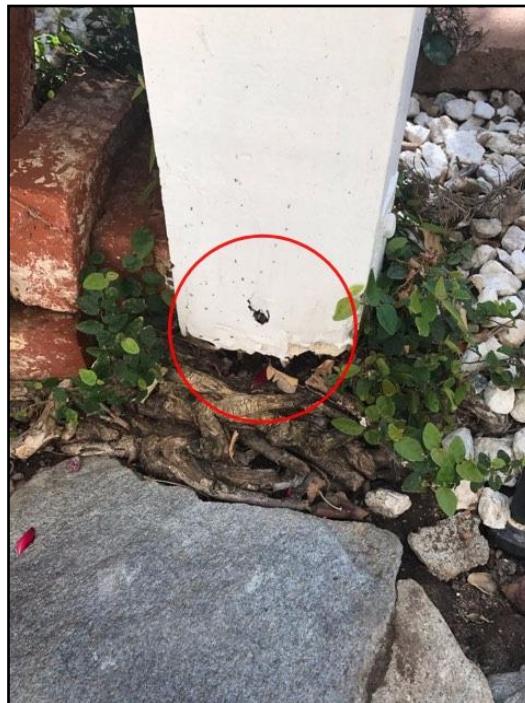
### 8. Condition: • [Rot](#)

Rot and/or insect damage noted. Wood to soil contact.

**Task:** Repair or replace

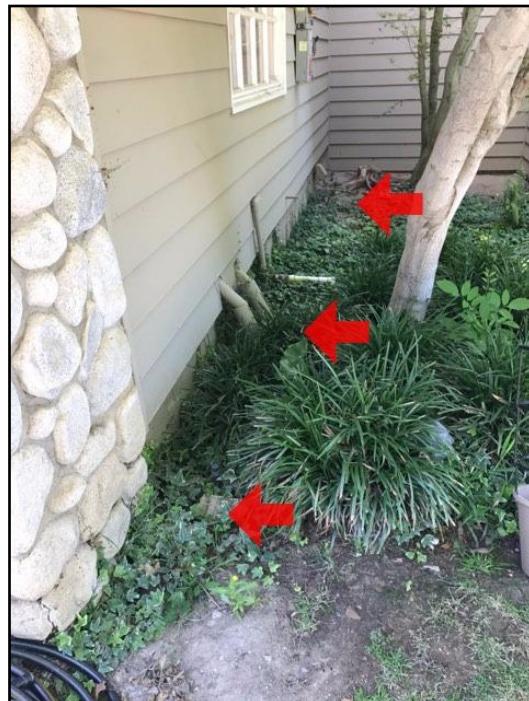
119. *Improper slope or drainage*

**10. Condition:** • [Improper slope or drainage](#)

**Implication(s):** Chance of water damage to contents, finishes and/or structure

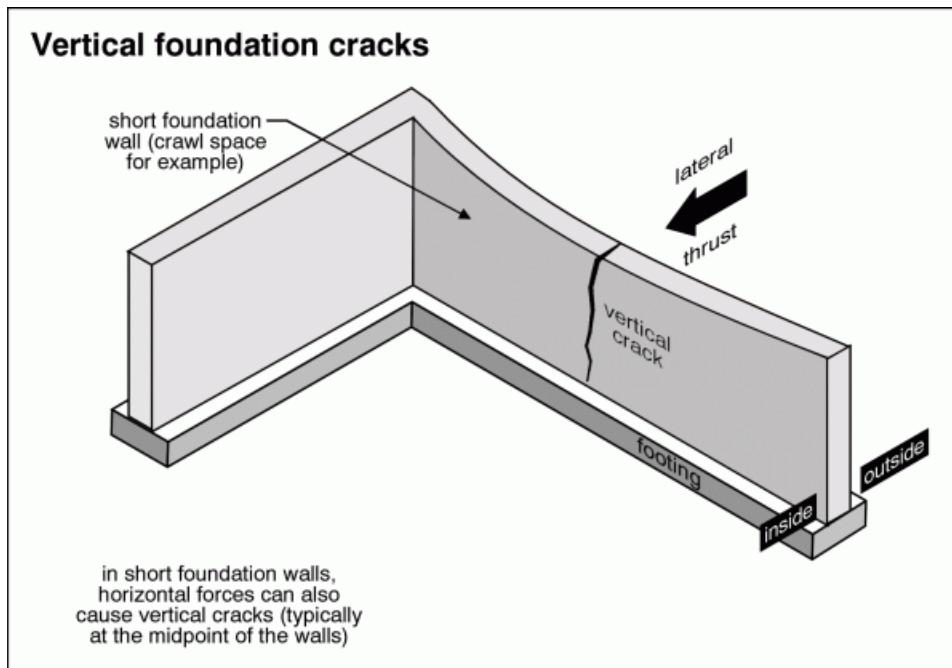
**11. Condition:** • [Cracked](#)

Signs of cracks were noted to foundation. A licensed specialist may be recommended to further evaluate.

**Implication(s):** Chance of water damage to contents, finishes and/or structure | Weakened structure

**Task:** Further evaluation

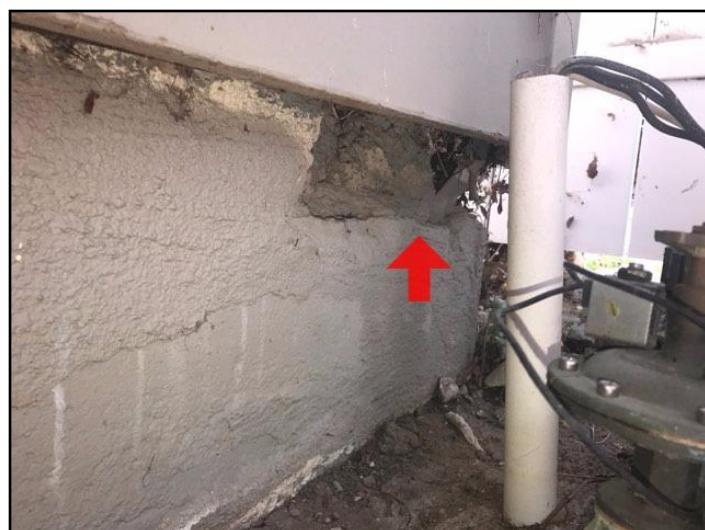
125. Cracked

**12. Condition:** • Cracked

Chipped concrete noted to foundation. Recommend further evaluation by a licensed professional.

**Implication(s):** Chance of water damage to contents, finishes and/or structure | Weakened structure

**Task:** Further evaluation

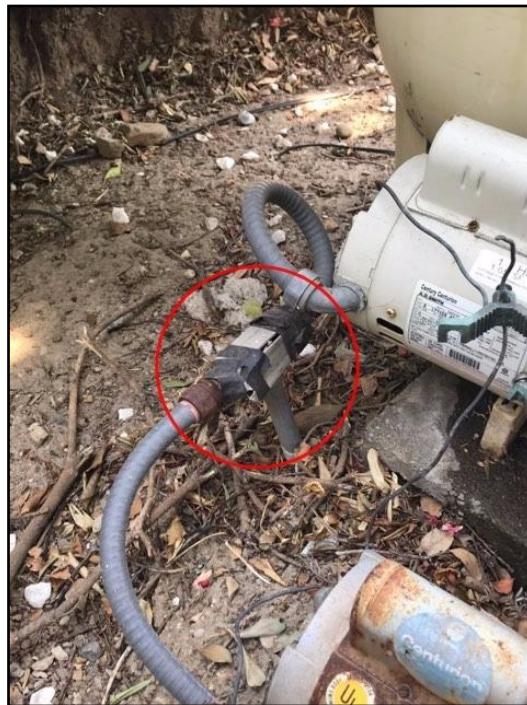
128. Missing, loose

**14. Condition:** • [Missing, loose](#)

Loose junction box noted. Recommend properly securing and/or replacement. A licensed electrical specialist may be recommended to further evaluate.

**Implication(s):** Electric shock | Fire hazard

**Task:** Correct

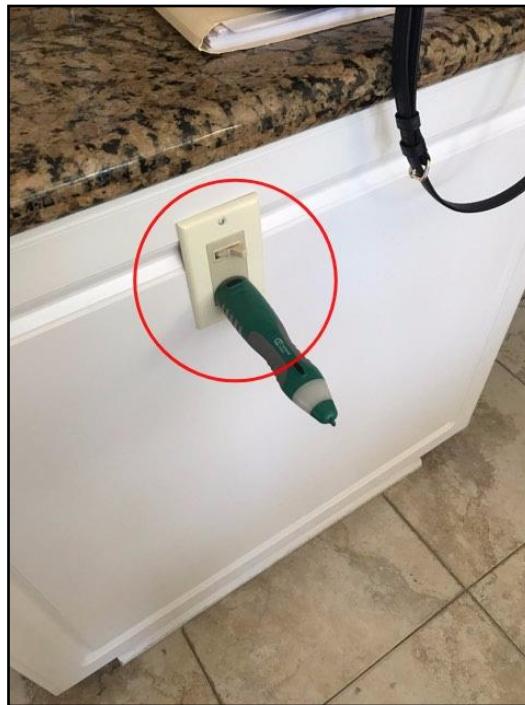
129. *Inoperative*

### 15. Condition: • Inoperative

Non functional outlet was noted. A licensed electrical specialist may be recommended to further evaluate.

**Task:** Repair or replace

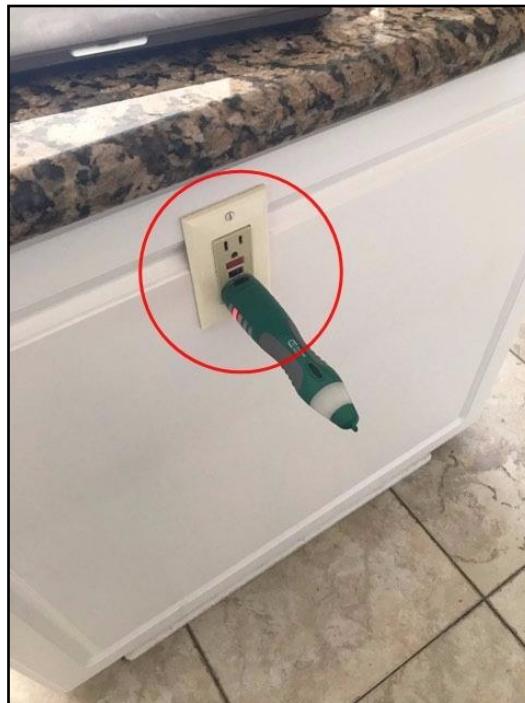
130. Ungrounded

**16. Condition:** • Ungrounded

Outlet was functional at the time of the inspection, however, bad ground was noted. Test faulty on GFCI due to bad ground. A licensed electrical specialist may be recommended to further evaluate and estimate cost for repairs.

**Task:** Repair or replace

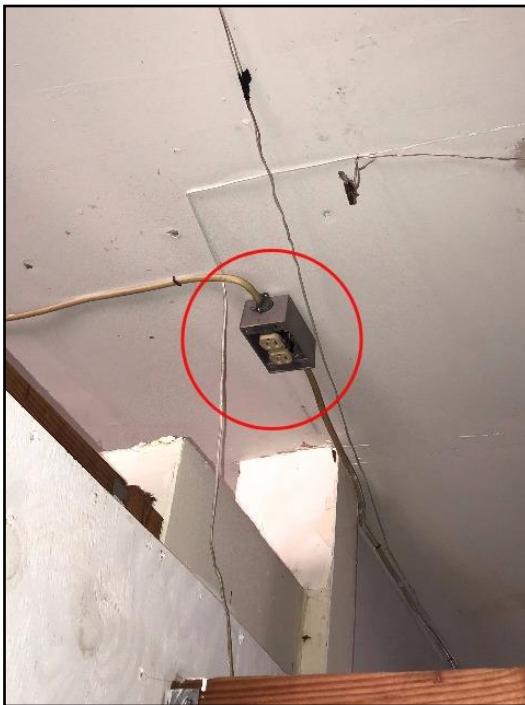
131. Missing

### 17. Condition: • Missing

Missing cover plate(s) noted. Recommend installing cover plates to prevent injuries from electrical shock.

**Task:** Provide

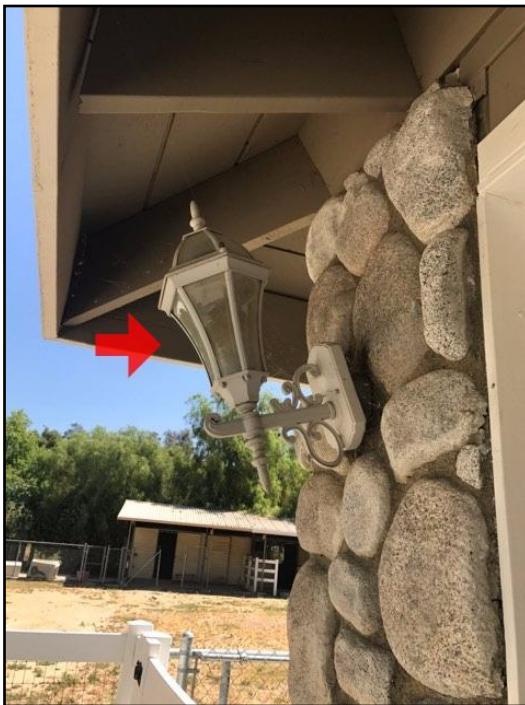
133. Loose

### 18. Condition: • Loose

Loose surface mount lights noted. Recommend repairs.

**Implication(s):** Electric shock | Fire hazard

**Task:** Repair

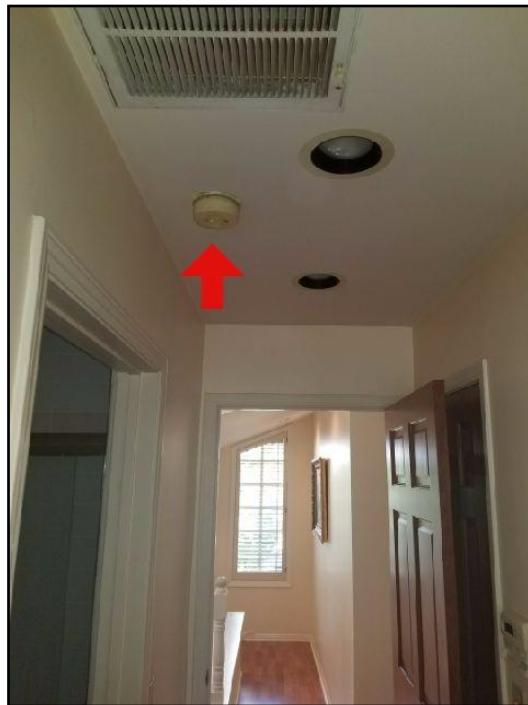
135. Inoperative

### 19. Condition: • Inoperative

Non functional smoke alarm noted. Recommend repairs and/or replacement.

**Implication(s):** Fire hazard

**Task:** Replace

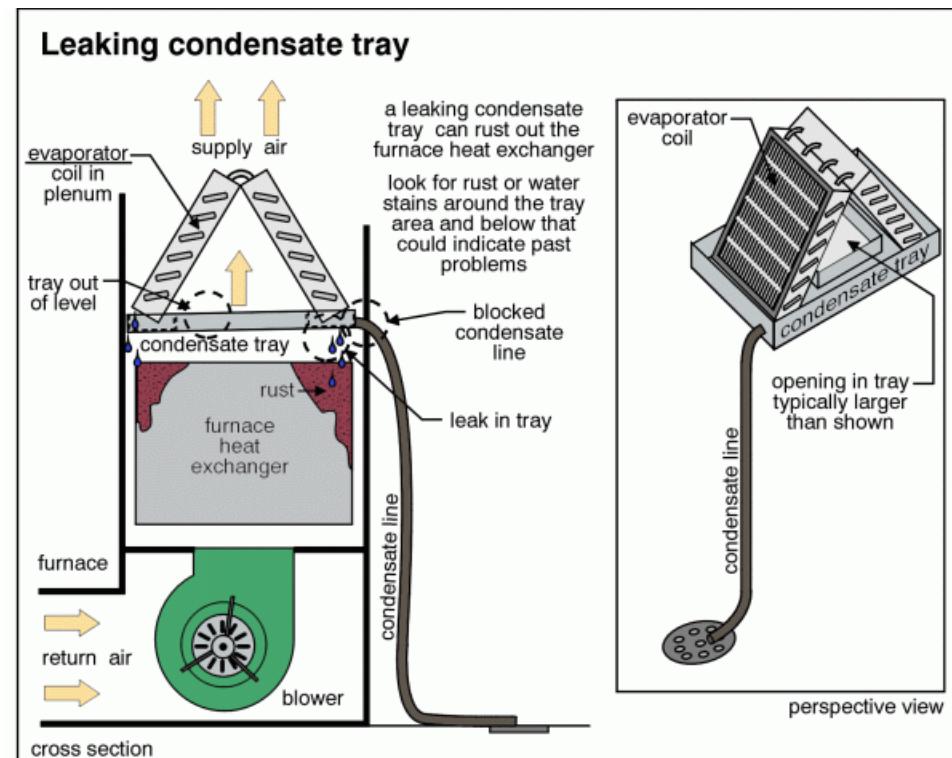
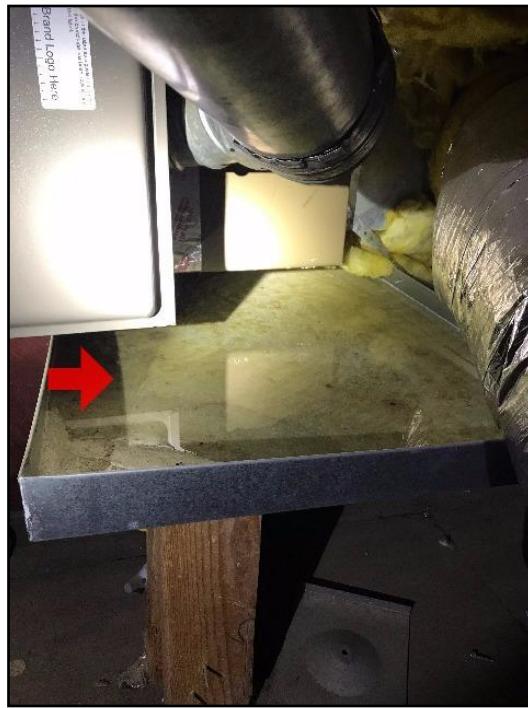
139. Pan overflowing

#### 20. Condition: • [Pan overflowing](#)

Water pooling was noted at drip pan. Signs of poor drainage at condensation drain pipes. A licensed HVAC specialist is recommended to further evaluate.

**Implication(s):** Chance of water damage to contents, finishes and/or structure | Damage to equipment

**Task:** Further evaluation

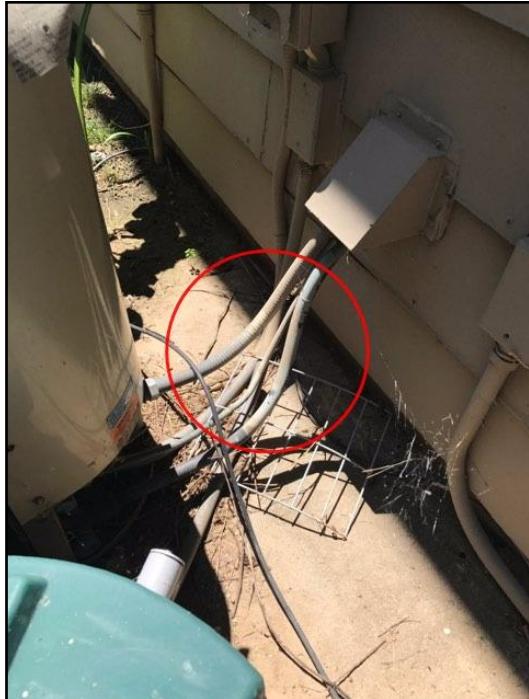
140. Insulation - missing

### 21. Condition: • Insulation - missing

Missing insulation noted. Recommend installing insulation to prevent lines from freeze.

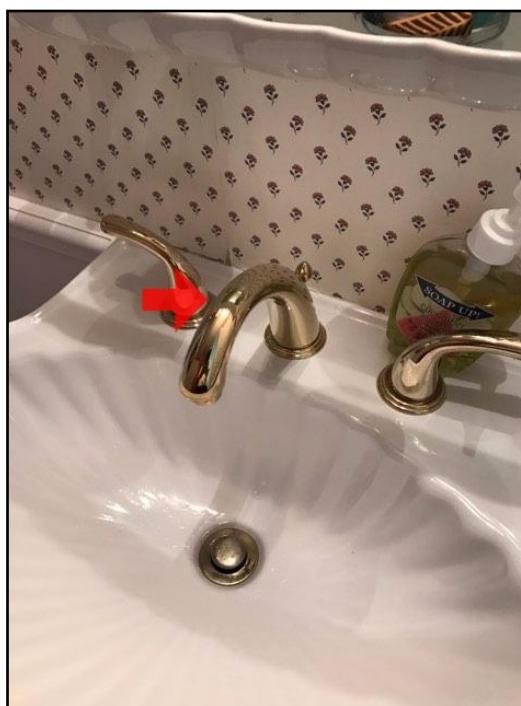
143. Loose

**22. Condition:** • Loose

Loose faucet noted.

**Task:** Repair or replace

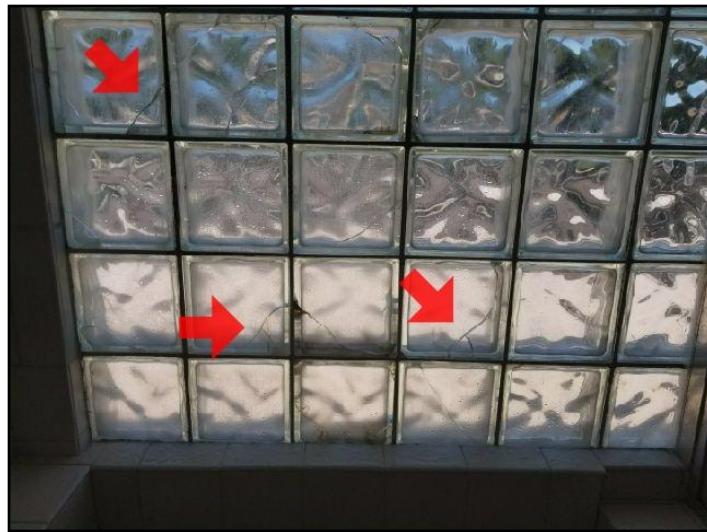
145.

**23. Condition:** • Cracked class noted. Recommend repairs and/or replacement.

**Task:** Replace

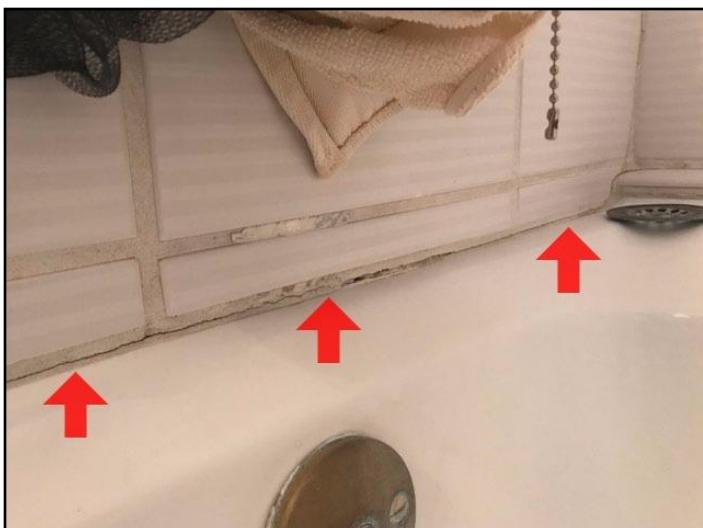
146. Grout loose, missing or deteriorated

## 24. Condition: • Grout loose, missing or deteriorated

Signs of missing caulking/grout noted. Suggest tub/shower edges, tiles be caulked and sealed to prevent moisture penetration. All missing, deteriorated/damaged caulking, grouting should be replaced, Failure to keep tub shower edges sealed can potentially cause deterioration and extensive moisture damage to the interior walls and surrounding sub-flooring. This damage is not always visible or accessible to the inspector at the time of the inspection.

**Implication(s):** Chance of water damage to contents, finishes and/or structure

**Task:** Repair

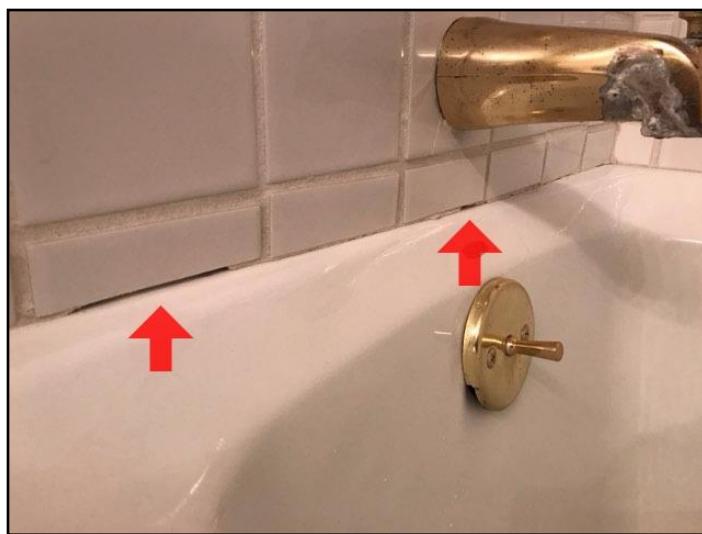
148. Grout loose, missing or deteriorated

**25. Condition:** • Grout loose, missing or deteriorated

Signs of missing caulking/grout noted. Suggest tub/shower edges, tiles be caulked and sealed to prevent moisture penetration. All missing, deteriorated/damaged caulking, grouting should be replaced, Failure to keep tub shower edges sealed can potentially cause deterioration and extensive moisture damage to the interior walls and surrounding sub-flooring. This damage is not always visible or accessible to the inspector at the time of the inspection.

**Implication(s):** Chance of water damage to contents, finishes and/or structure

**Task:** Repair

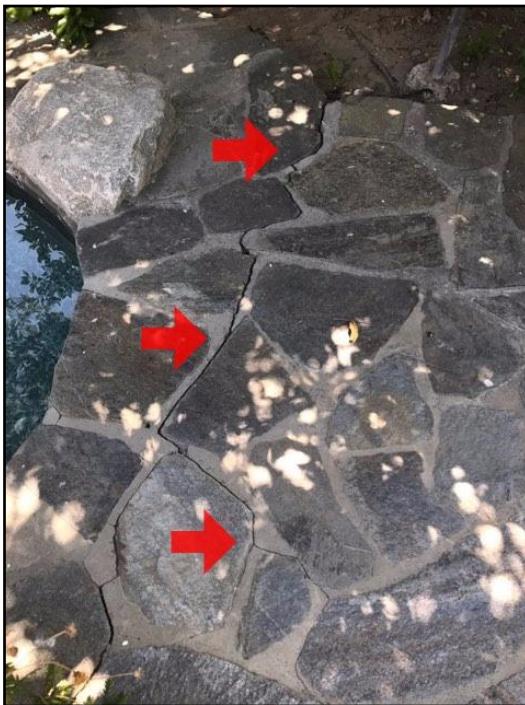
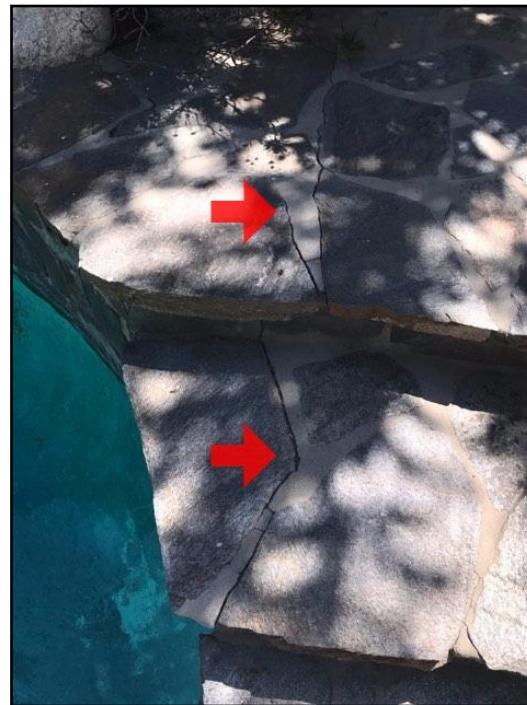
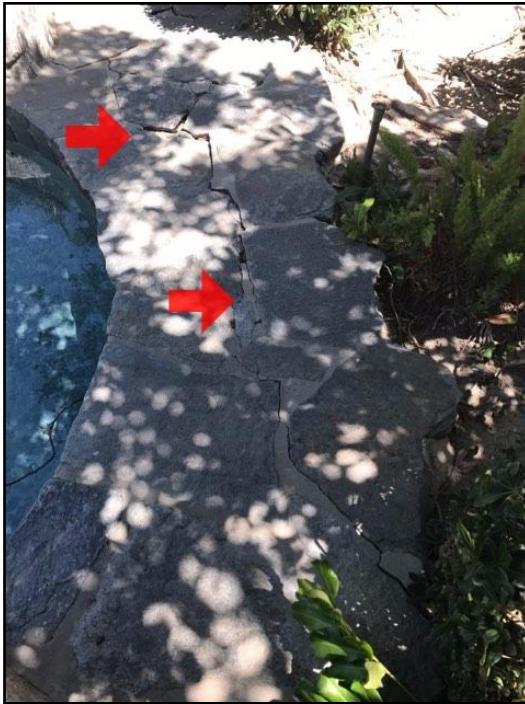
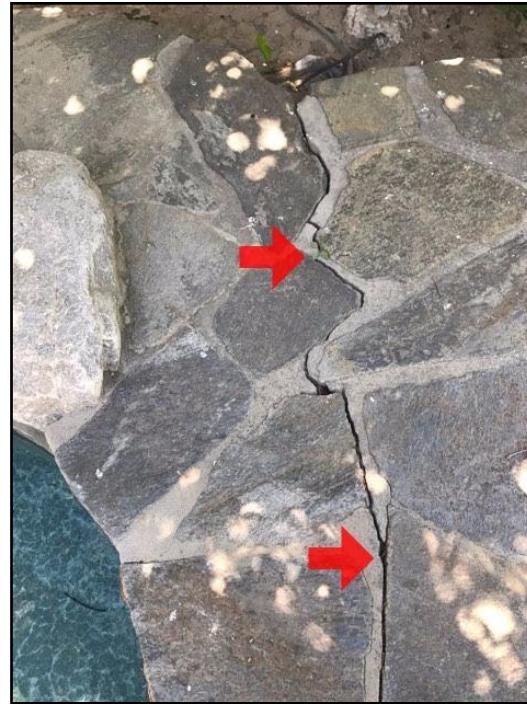
**26. Condition:** • Surrounding deck/concrete cracked

Cracks were noted to concrete pool deck. Recommend sealing cracks to prevent from further expansion. If requested, a licensed specialist may be recommended to further evaluate.

**Implication(s):** Material deterioration | Equipment not operating properly | Physical injury

**Task:** Further evaluation

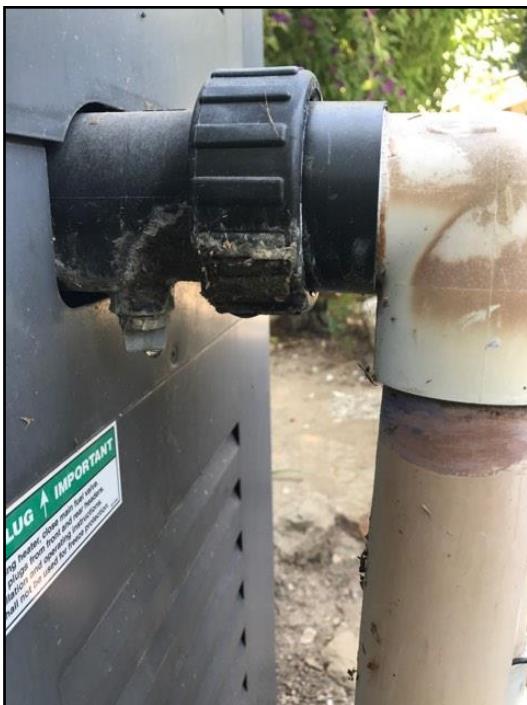
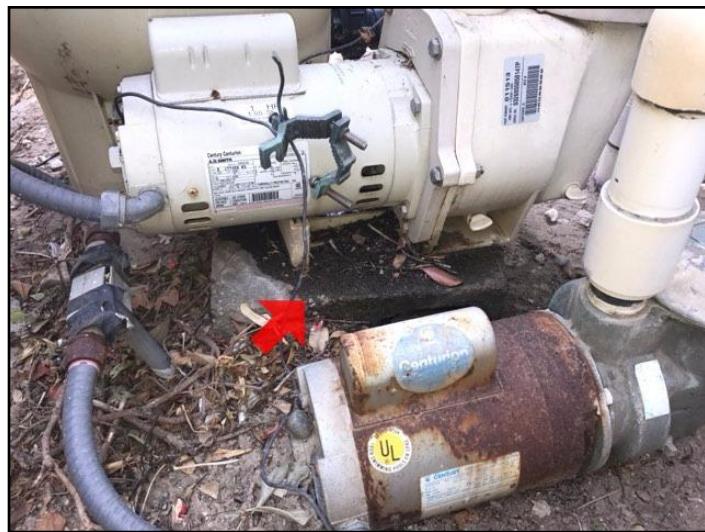
### 27. Condition: • Pump leaking

Leak noted at pool pump. A licensed pool specialist is recommended to further evaluate.

**Task:** Repair

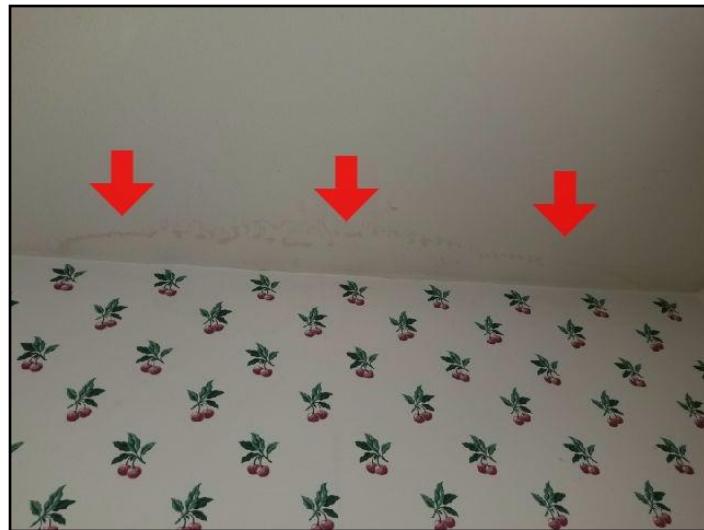
#### **28. Condition:** • Stains

Signs of water/moisture stains were noted to ceiling. Recommend monitoring. A licensed specialist may be recommended to further evaluate.

**Task:** Further evaluation, Seller disclose

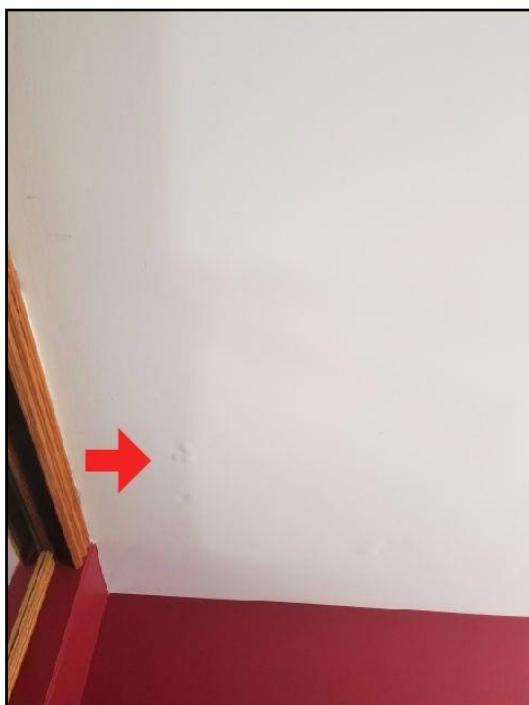
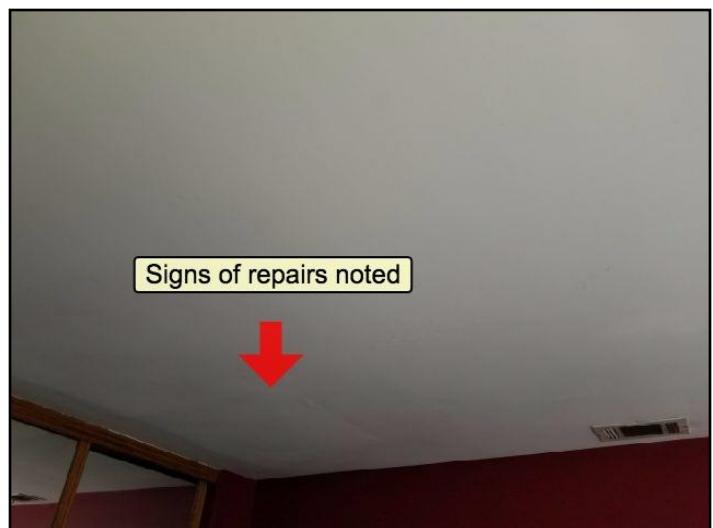
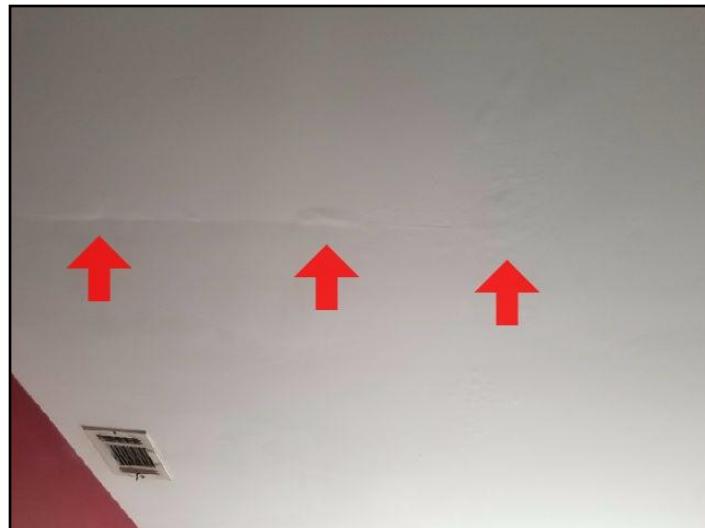
**164. Stains****29. Condition:** • Water stains

Ceiling was observed and evidence of deterioration/bubbling surface was noted. A licensed specialist may be recommended to further evaluate.

**Task:** Further evaluation, Seller disclose

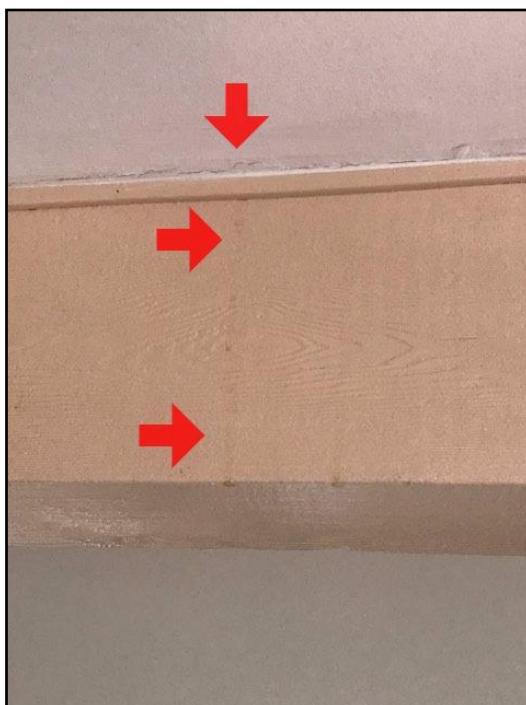
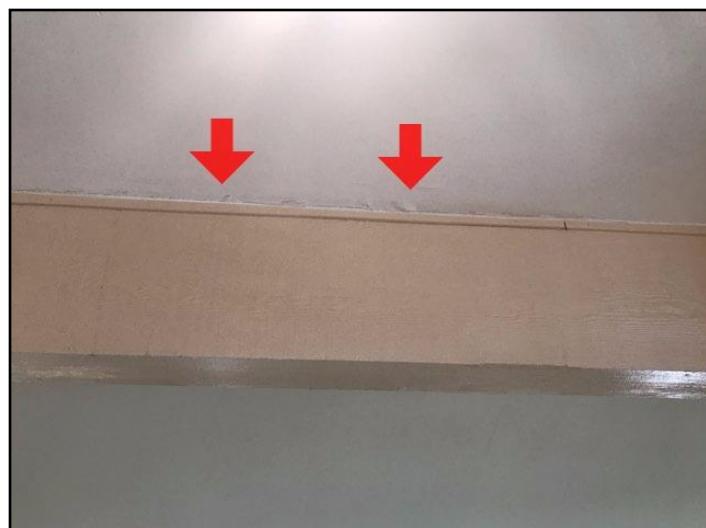
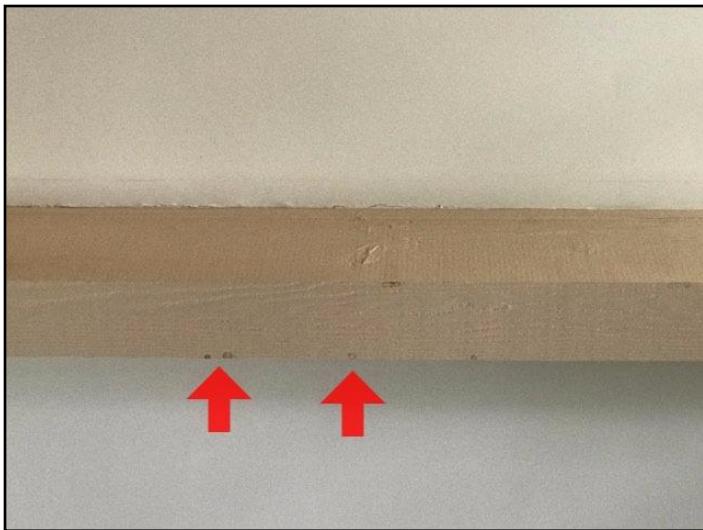
**30. Condition:** • Water stains

Signs of water stains, deterioration was noted. Recommend further evaluation by a licensed specialist. Recommend seller disclose.

**Task:** Further evaluation

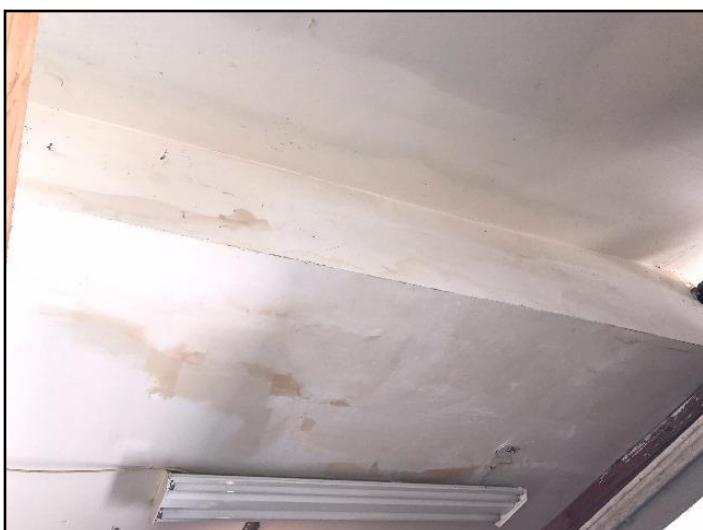
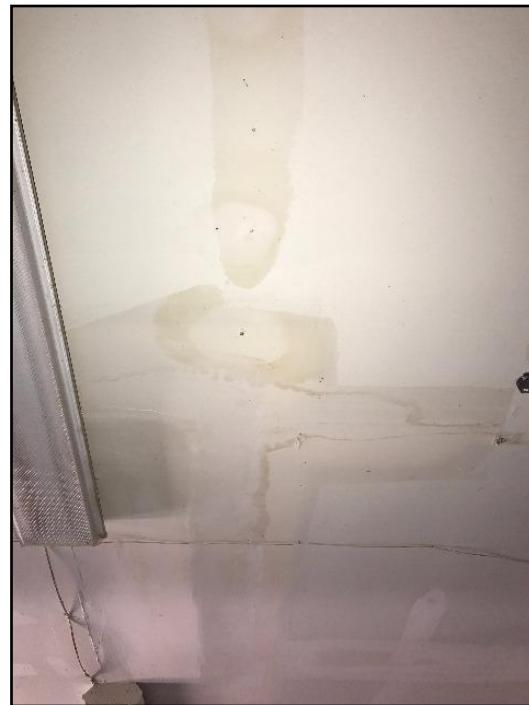
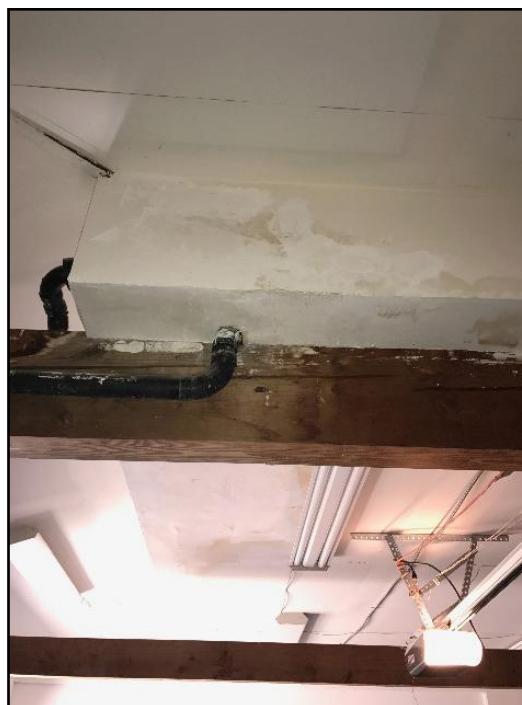
**31. Condition:** • Water stains

Signs of water stains was noted to ceiling. Master bathroom at 2nd floor is above the area where the moisture stains were noted. Recommend further evaluation by a licensed specialist. Recommend seller disclose.

**Task:** Monitor Request disclosure

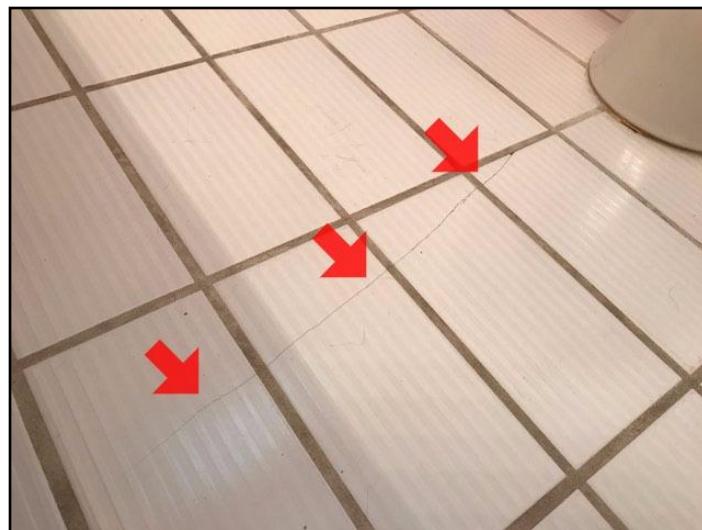
175. Tiles cracked

### 32. Condition: • Tiles cracked

Cracked tiles noted

**Implication(s):** Trip or fall hazard**Location:** Second Floor Hallway Bathroom**Task:** Repair or replace**Time:** Immediate**Alternatives for installing ceramic tiles****(A)**

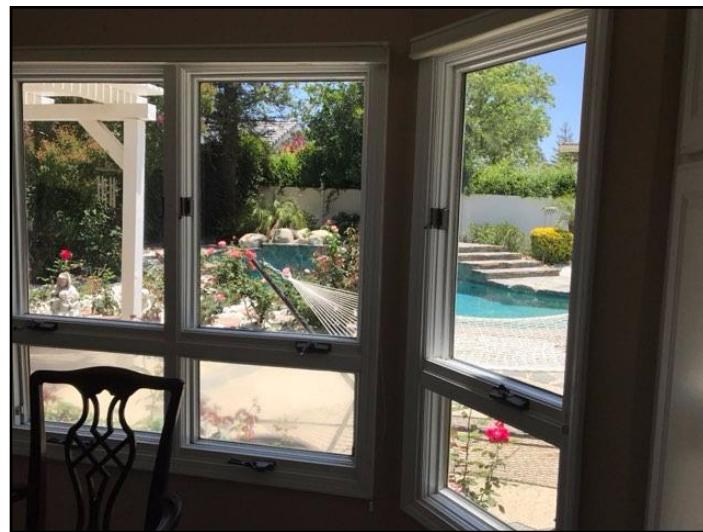
176. Difficult to operate

### 33. Condition: • Difficult to operate

Difficult to operate. Hard operation was noted to window. Recommend repairs for ease of operation.

**Task:** Improve, Correct

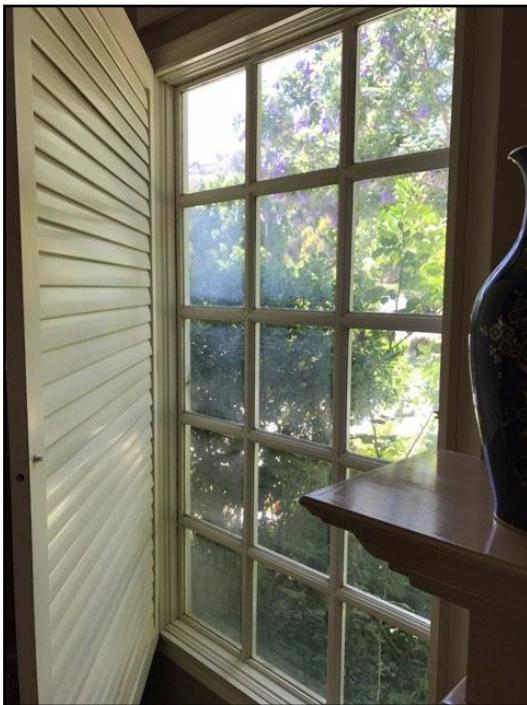
177.

### 34. Condition: • Gaps noted. Recommended sealing and/or caulking.

**Task:** Correct

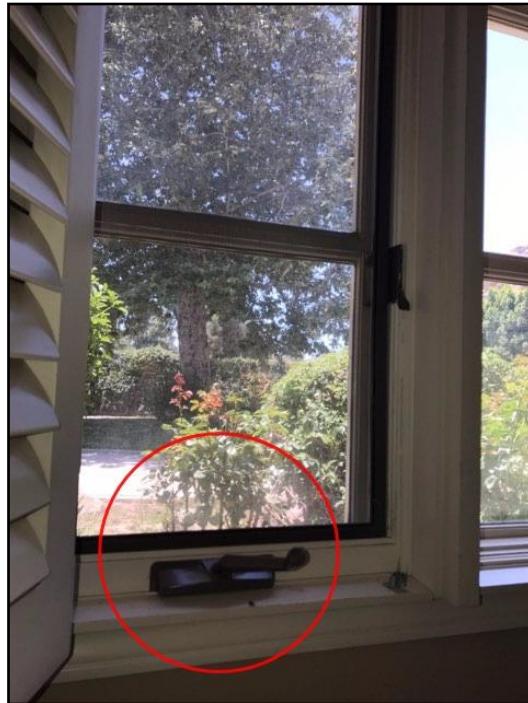
**WINDOWS \ Hardware****35. Condition:** • Inoperative

Inoperative windows noted. Recommend repairs for ease of operation.

**Task:** Repair or replace

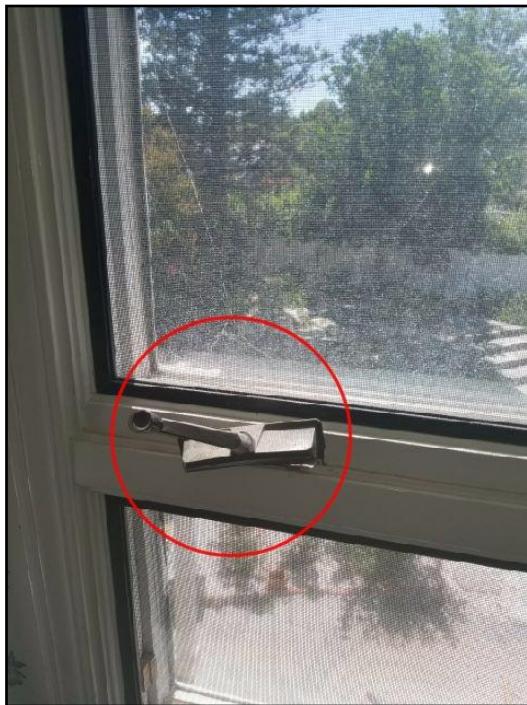
180. Inoperative

Inoperable windows noted. Recommend repairs for ease of operation.

**Task:** Repair, Further evaluation

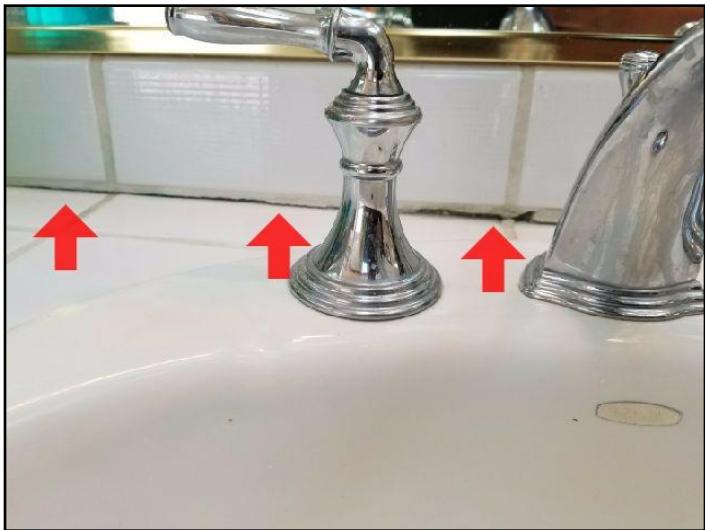
185. Grout loose or missing

### **38. Condition:** • Grout loose or missing

Missing grout noted. Recommend repairs to prevent deterioration to cabinet or walls from water moisture intrusion.

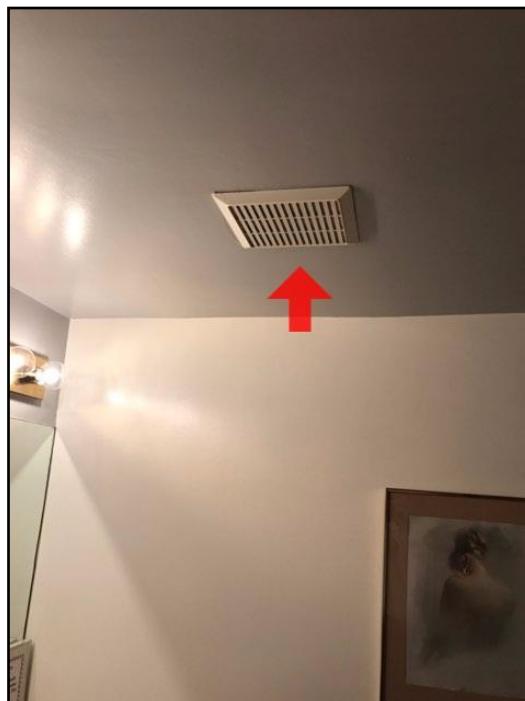
### 39. Condition: • Inoperative

Non functional exhaust fan noted.

**Implication(s):** Chance of condensation damage to finishes and/or structure

**Task:** Repair or replace**Time:** Immediate**Exhaust fan conditions**

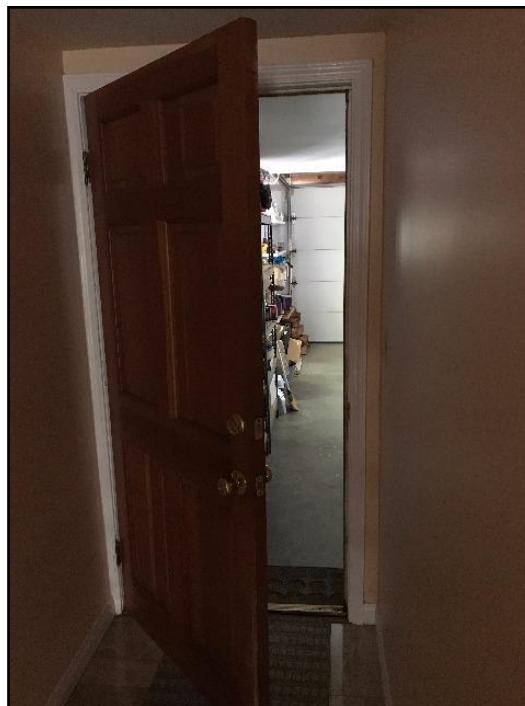
Garage door between garage and kitchen was not auto closing. Recommend repairs.

**Implication(s):** Hazardous combustion products entering home

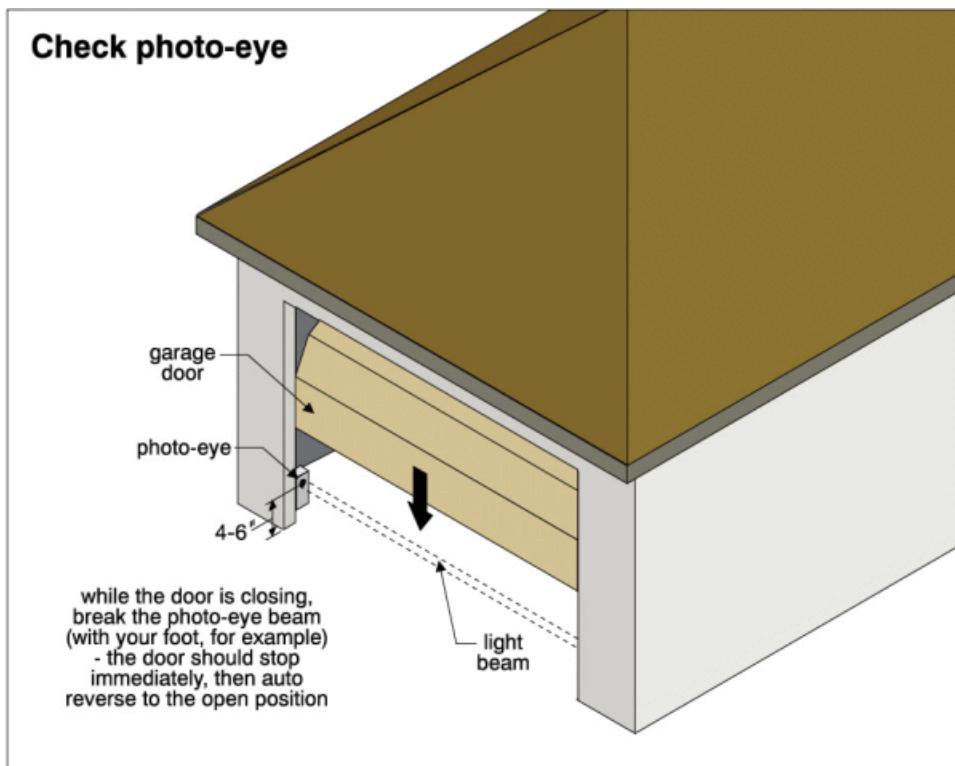
189. Sensors inoperative

No garage door sensors were present. This is considered a safety hazard and requires installation of sensors.

**Task:** Provide
