# INSPECTION REPORT

CHATSWORTH, CA 91311

Inspection Date: Friday, June 9, 2017

RE: Report No. 1117, v.2

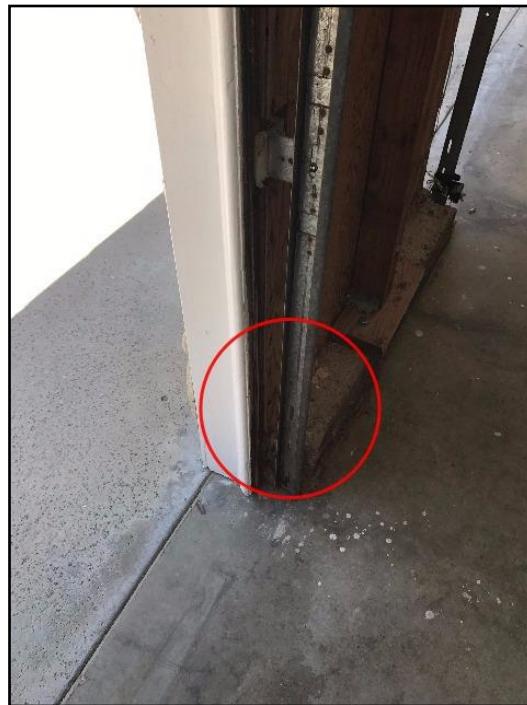
190. Sensors inoperative

No garage door sensors were present. This is considered a safety hazard and requires installation of sensors.

**Task:** Provide
